PERMITTING SIGNICANT HARM IN THE CONSERVATION OF HERITAGE ASSETS: CONFLICTS IN SUSTAINABLE LAND USE PLANNING DECISIONS

DR HAZEL ANN NASH

Centre for Engineering and the Built Environment, Birmingham City University, UK

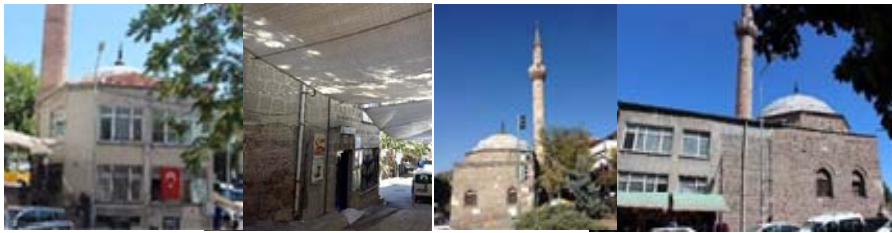
Figure 8: North, east, south, and west facades of the mosque (from left to right) (Source: Archives of the authors, 2016, 2018).

Built in the 16th century, it is designed in the Classical Ottoman style (central plan mosque style), with one large main central dome above the main prayer area [11]. The structure has two story main body walls with a square plan covered with a dome. The dome has an octagonal drum. There is a circular minaret located on the northeast façade of the mosque rising above a pentagonal base with a single balcony, and a pointed cone. After the earthquake in 1921 it was renewed [11]. The late comers' portico of the mosque was closed first with a one-way sloped roof. Then it was built again in 1972 enlarged with a two-story concrete column and beam system [11-12]. This new addition is used for

women's prayer space and children's education and its basement floor is used for toilets, ablution hall, and for water depot. Neither the material selection, nor the form, geometry, and style of this new addition is compatible with the old mosque, such that it totally prevents the visibility of the original mosque on the north façade [21]. The mosque itself still preserves its original function as a prayer place. The exterior finish of the mosque is rubble stone with alternating brick rows façade detailed with rectangular windows at the first level with pointed arched brick pediments, pointed arched windows at the drum level, and a dome topped with a copper finial (Fig. 8). At the interior the main prayer area is covered with a dome with squinches on the corners (Fig. 9 and Fig. 10). There is a plaster mihrab with muqarnas niche, and with Qur'anic inscriptions, geometric bordures, rosettes, and ornaments on the south façade of the main prayer area. There is not any historic value of the wooden minbar, and it is dated to recent history [11]. Kursunlu Mosque was repaired in 1914 by the local community, and then in 1990 by Directorate General of Foundations, in 1982 its minaret was repaired and repointings of main body walls were renewed [12], [22]. On the 31st March 1964 it was registered as a historic place by the Conservation Board of Historic Properties [22].

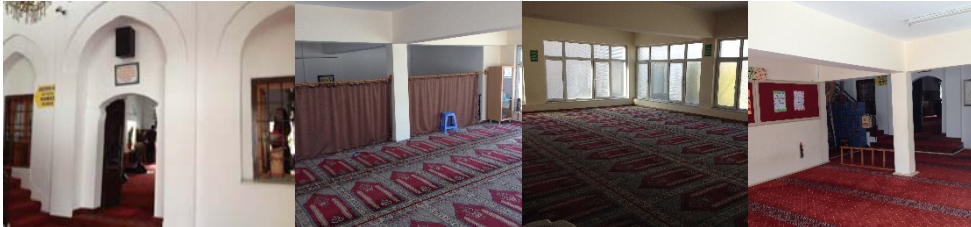
Figure 9: Interior views of the mosque and the new addition on the north side (Source: Archives of the authors, 2016, 2018).

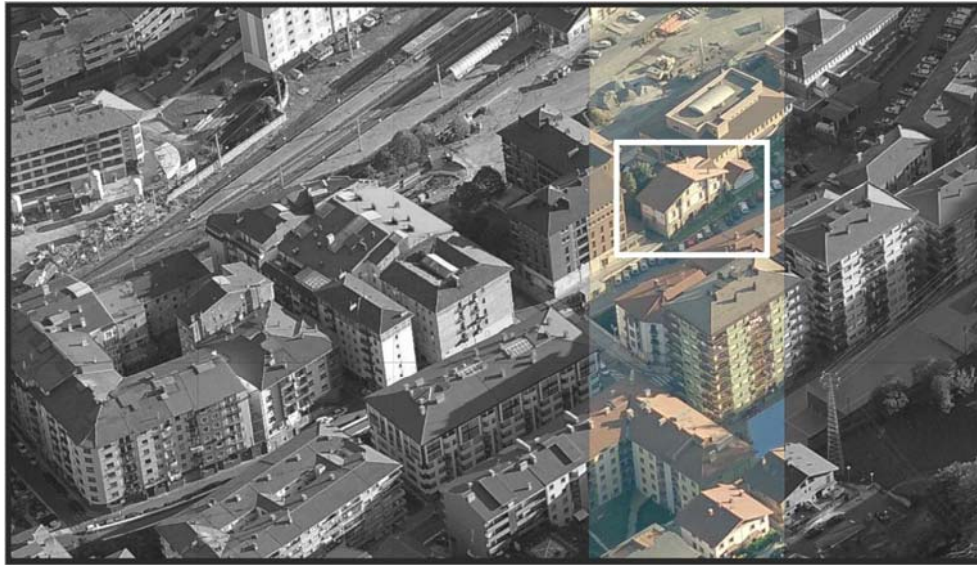
Figure 2: Current situation of the Zumarraga former railway station.

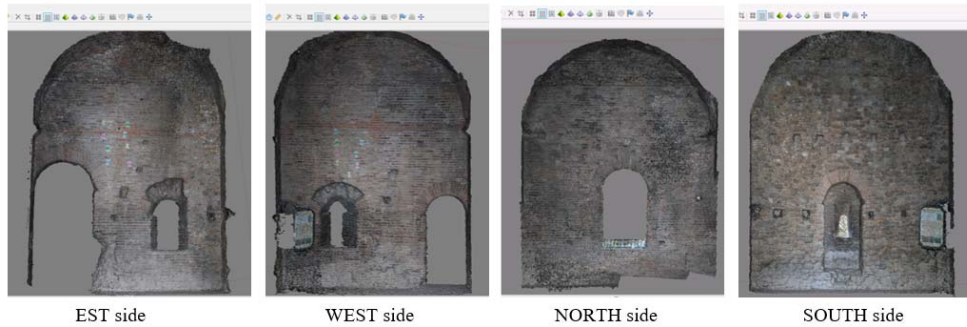
At the same time, for each wall a dense cloud was created (Figure 6) with the aim to reconstruct and define the complete cracking framework of the EAST and WEST wall.

Figure 6: Dense cloud points of the walls

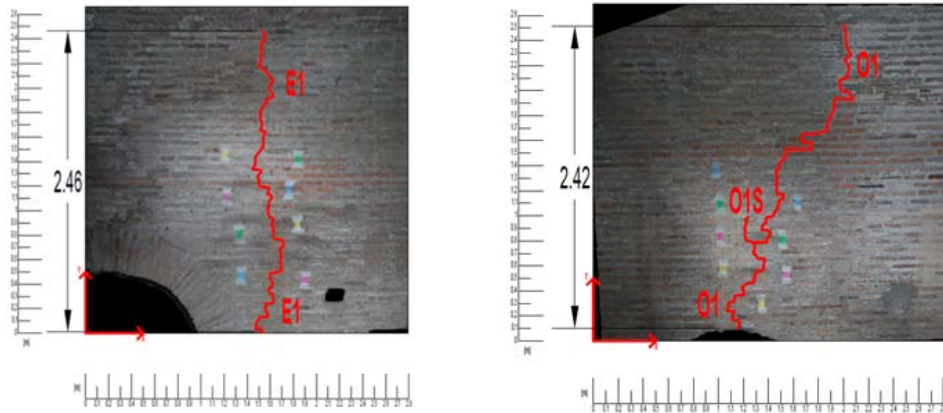
where D_H and D_V respectively represent the width and height of the image footprint on the photographed object. The GSD is equal to 0.34 mm/px that represents the resolution of the model.

Figure 7: Crack patterns detection

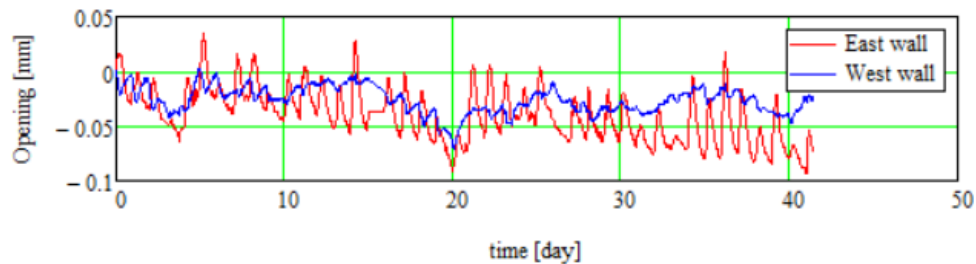
Figure 8 shows a sample of acquired data; data are given with temperature compensation, so that they effectively show the pure geometric opening of the cracks.

Figure 8: Time history of crack opening - continuous monitoring interval of 42 days

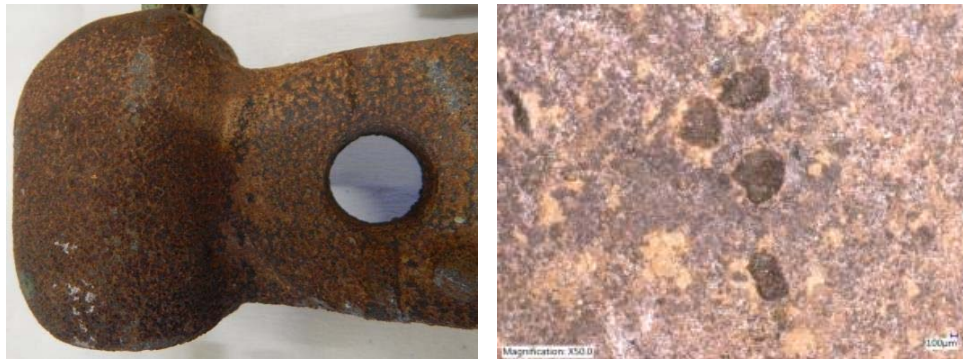
Figure 1: Surface of cast iron after 50 years of exposure – graphite particles.

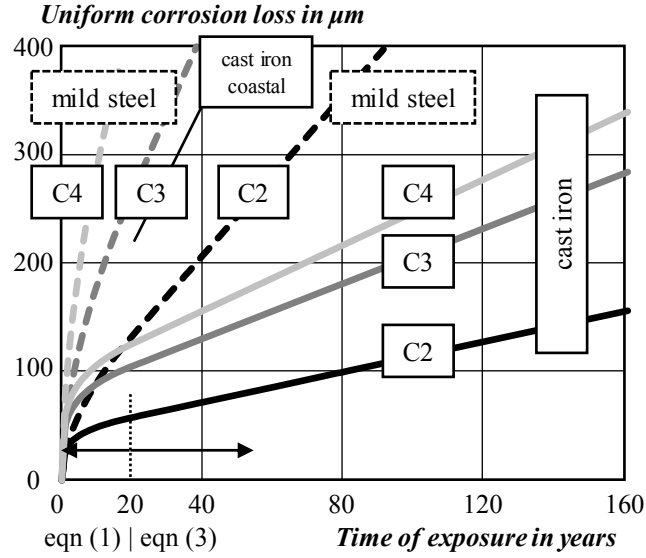
Figure 2: Variation of uniform corrosion loss with time of exposure for mild steel (model according to ISO 9224) and for cast iron (proposed model with the parameters from Table 3).

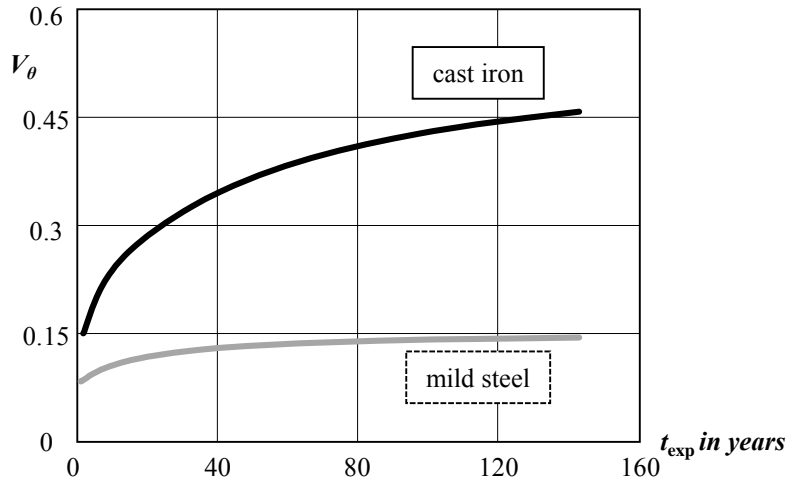
Figure 4: CoV of corrosion loss as a function of time of exposure for mild steel and cast iron.

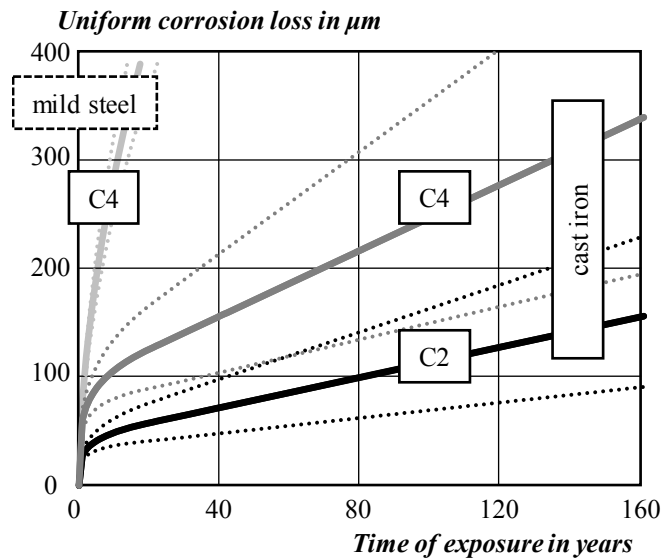
Figure 5 shows the variation of corrosion loss with time of exposure for mild steel and cast iron in various environments – the expected trends (also plotted in Figure 2) and 75% confidence intervals. A lower bound is obtained by multiplying the expected value by a 12.5% fractile of the uncertainty θ ; an upper bound by multiplying by an 87.5% θ -fractile. In the case of cast iron, the uncertainty in a corrosion loss estimate is large and it is recommended to update the regression model.

Figure 5: Variation of corrosion loss with time of exposure for mild steel and cast iron – expected trends and 75% confidence intervals.

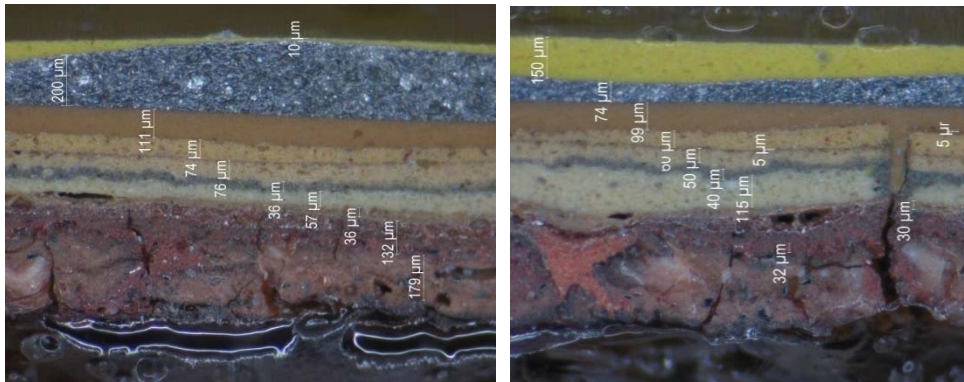
Many cast iron structures were repainted without removal of previous layers and the thickness of coatings may reach 1000 μm . Figure 6 shows at least ten paint layers after more than 100 years of exposure of a cast bridge. Thicknesses of layers are scattered. Lower layers are discontinuous with a lot of vertical and horizontal cracks. The top layer is then significantly degraded – the paint is chalking. The lowest paint layer is mixed with corrosion products.

Figure 6: Example of stratigraphy of the paint system on a cast iron structure.

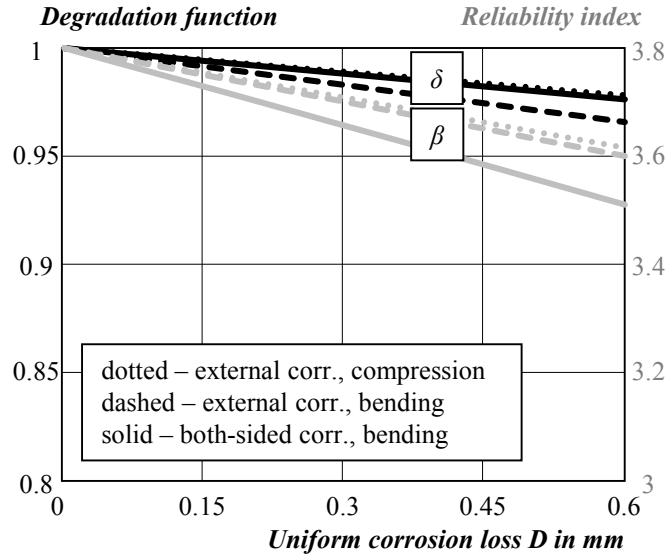
Initially, a typical ‘massive’ cast iron column is considered. The dimensions are taken from the column that supports a roof structure at a railway station in the Czech Republic. Without corrosion losses, the external diameter is $\emptyset = 219$ mm, thickness of the wall is 32 mm, and the inner diameter is thus $\emptyset_{\text{in}} = 155$ mm.

Figure 7: Variation of the degradation function (black curves) and of reliability index (light grey curves) with uniform corrosion loss for one- or both-sided corrosion of the massive column in compression or in bending.

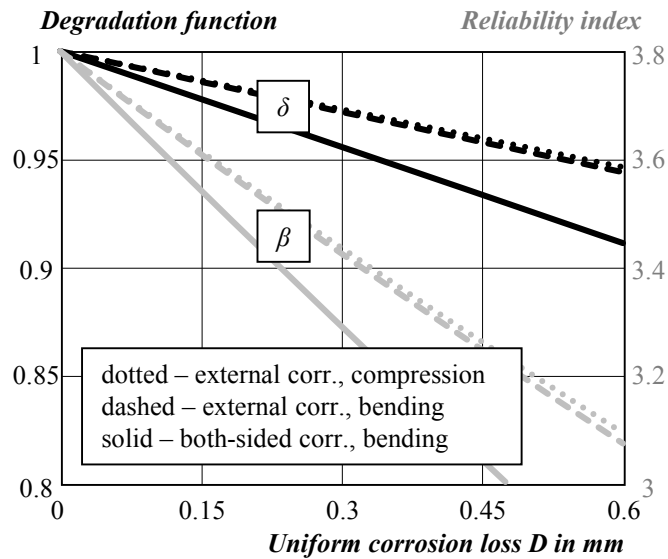
Figure 8 shows the degradation function and reliability index as functions of corrosion loss for the thin-walled column. It appears that corrosion losses around 0.5 mm leads to significant decrease of reliability index that drops from $\beta = 3.8$ to about 3.0.

Figure 8: Variation of the degradation function (black) and of reliability index (light grey) with corrosion loss for the thin-walled column in compression or in bending.

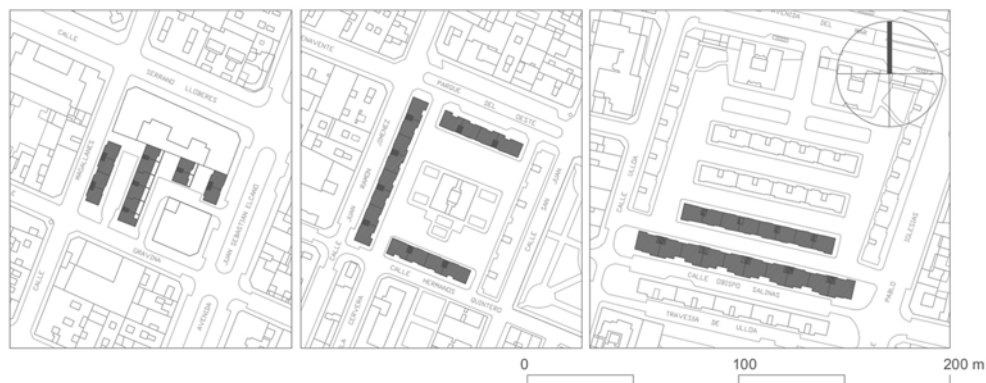
Figure 2: Site Plans. Group 1, Group 2, Group 3. Source: Own elaboration. 2019.

In the two groups located in the capital, the linear buildings delimit the perimeter of the block and the inside is occupied by other residential buildings, in one of the cases with the same type of building and in the other with a residential tower. Only in the case of the group located in Grao, the whole plot is occupied by linear buildings, arranged in parallel throughout the width of the block.

Consistent with this building rationality and its link with the functionalism of the first modern architecture, the inner spaces between buildings are equipped with inner streets and a large number of parking.

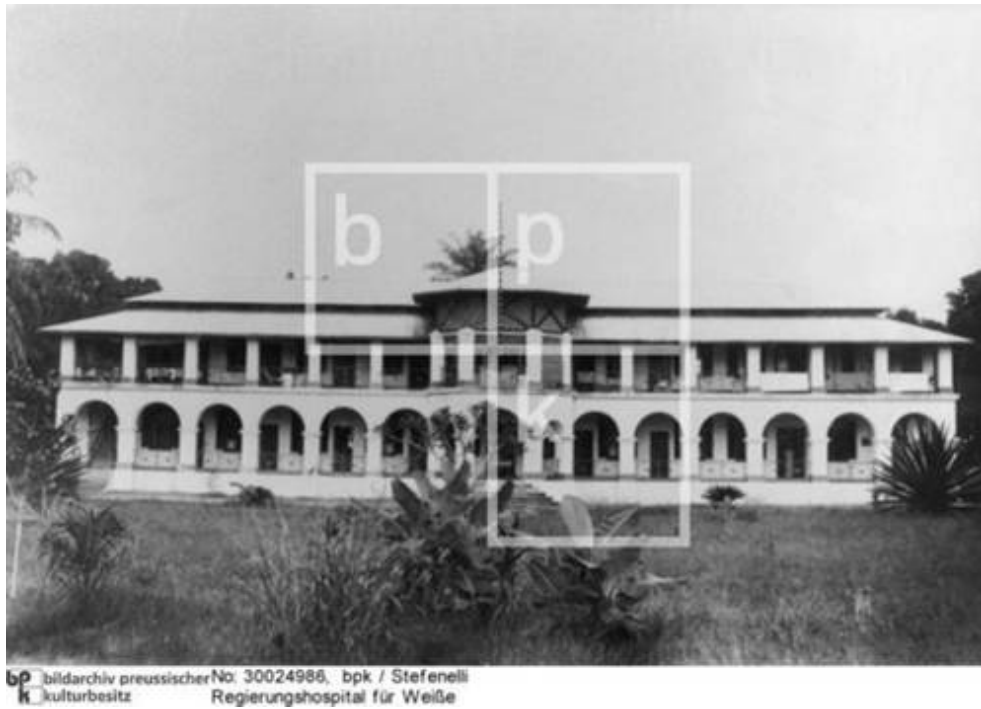
Figure 2 : First building of the Europeans Hospital in Douala, 1902 [9].

In the particular case of the Europeans’ hospital in Douala, the evolution of the building attests of the experimental character of its architecture. Initiated by Dr. Albert PLEHN, the hospital was built in 1896, with Henri DREES as project manager. This first pavilion, comprising 16 rooms in R+1 form, measured 42 meters. Building much admired in its time, including by the German administrators, a second segment of the same architecture reinforced it. After the departure of the Germans, France gives it its current look, adding a third building in 1930, still respecting the original architecture [8]. Lack of elements of archives do not allow presenting architectural plans of that building. Following pictures give nevertheless an idea of the building.

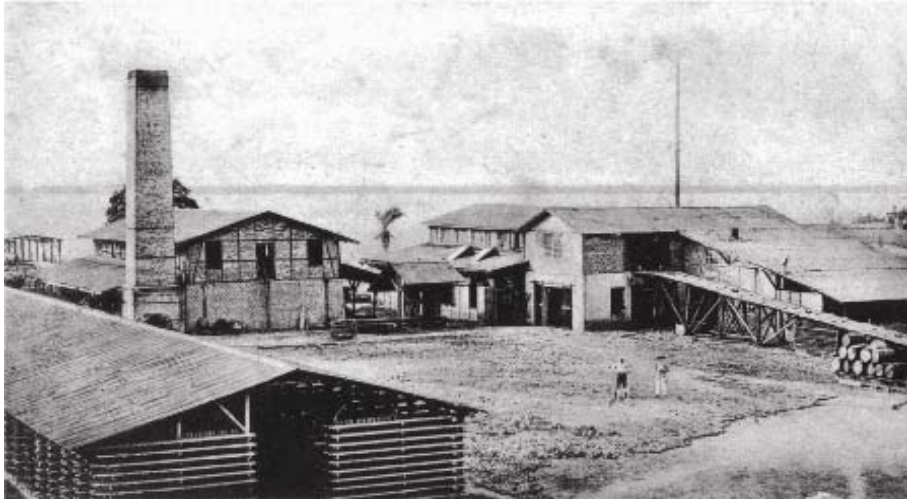
Figure 4 : German Water treatment complex [10].

This complex is built with temporary material, including wood and clay. All indications are that the project of its construction did not provide for a definitive implantation. The same remark is valid for the building of the Régie des Chemins de fer, which is another testimony of the absence of an inspiration or the aesthetic insufficiency of some colonial buildings in Douala. Therefore, it seems wrong to summarize the colonial architecture in Africa to a modernist architecture.

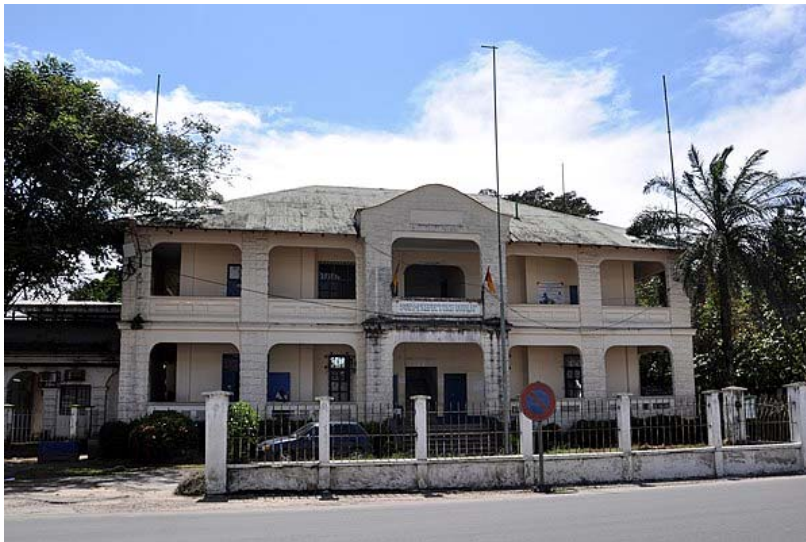
Figure 6 : Government Headquarters in Douala [12].

One of the relevant examples of buildings that symbolize the European domination and power is the First Government Headquarters, built in 1891. It has an R+1 structure, and covered with a sheet metal roof. Some authors argue that this is the period the majority of buildings in Douala were made of fair quality material. Germans decided to import modern building material from Hamburg as some authors point it out: “la majorité du bâti était constituée de petites maisons en torchis et toitures végétales comme le montrent les photographies anciennes. Soucieux de s’inscrire dans la durée, ils (Germans) élèvent pendant la première quinzaine d’années, des édifices en utilisant des matériaux importés de Hambourg, bois, briques et ciment, structures métalliques pour le gros œuvre, tôles et tuiles pour les toitures”[11].

Beyond the material for its construction, the headquarters of the first government of colonial Cameroon symbolizes the power of Germany. Its structure is similar to most of the buildings of German royalties in its European and African territories. One of its best short description is of Hervé – Brice Ngembou: “L’édifice reposait sur un socle d’un mètre de haut, les murs étaient en briques, les planchers en planches ‘*Metlasch*’ importés. Les plafonds étaient en tôle ondulée posée sur des solives métalliques et recouverte d’une couche de ciment. Le toit enfin était en bois recouvert de carton bitumé. L’aile principale comportait onze pièces”.

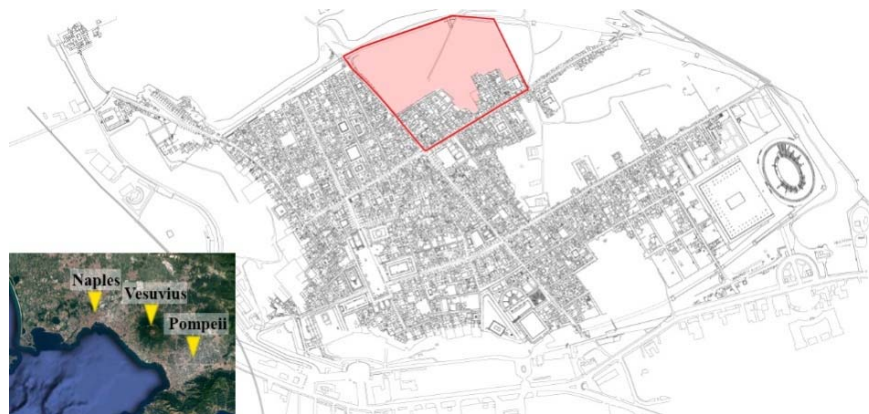
Figure 1: Location of Pompeii near the city of Naples and the Vesuvius and plan of Pompeii archaeological site with the indication of the *Regio V* borders (red line) and the new archaeological excavation work area in the *Regio V* (red area)

From May 2018, new archaeological excavation work was initiated in the *Regio V* of Pompeii archaeological site (Figure 1).

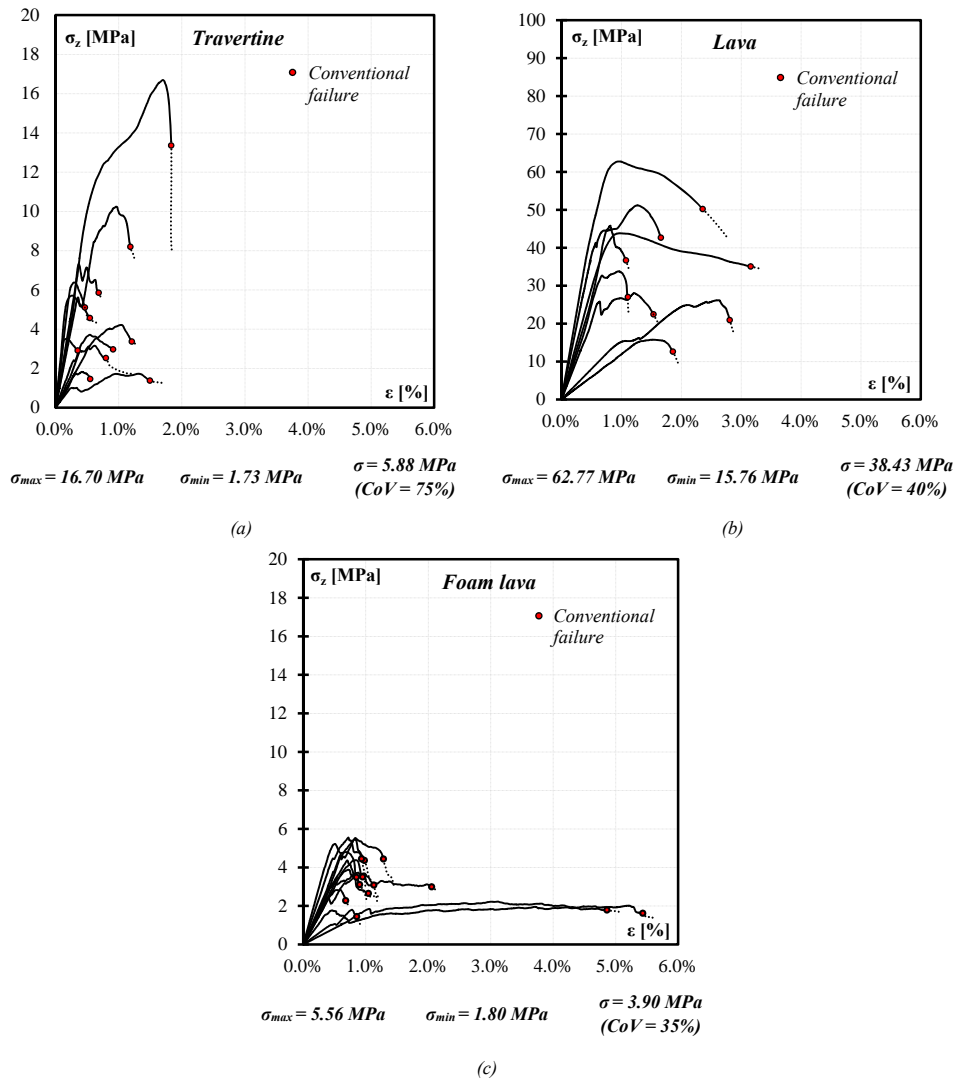
Figure 5: Axial stress-axial strain relationship. (a) Travertine cubic specimen. (b) Lava cubic specimen. (c) Foam lava cubic specimen.

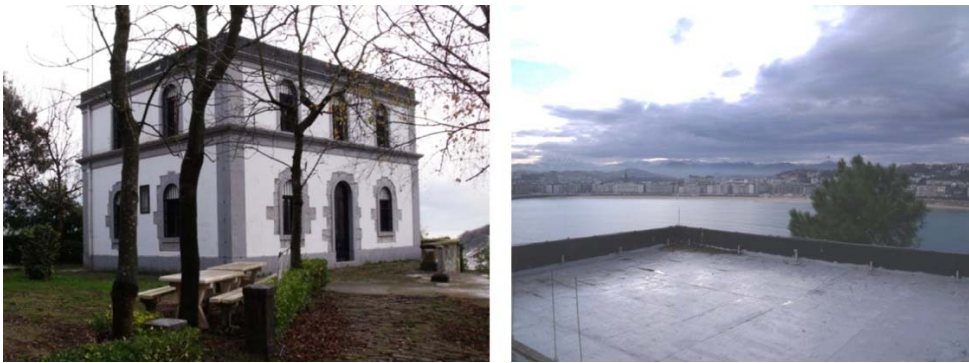
Figure 4: General aspect of the building today. Current flat roof.

impossible to attest the changes that took place in the lighthouse, changes that are obvious but very small in number. From the constructive viewpoint, it is only detected, with respect to the current situation, that the under-roof floor is consolidated as a second floor with flat roof (Fig. 4). The authors consider that this modification was carried out immediately after the construction of the lighthouse for several reasons. It is even possible that originally, the definite aspect was as observed today, and that the drawing shown in Figure 6 is an indicative preliminary project. This fact has been observed in hundreds of documentary collections of other lighthouses analysed (e.g., the Lighthouse of Oropesa), where the original projects were changed as the definite construction date approached. The modification to include two storeys and a transitable flat roof simplified the work related to the exterior upkeep and maintenance of the tower. On the other hand, it increased the working area of the building of living quarters, office and small workshop. The spatial distribution of the new floor is identical to the lower floor without having to overburden the structure. In the case of the Lighthouse of the Island of Santa Clara, this new floor, accessed from the tower staircase (Fig. 5, left), contained three bedrooms and a full bathroom, leaving the ground floor for dining room, kitchen, toilet, office and small workshop. The water tank is located on the new flat roof, which was filled from the cistern using manual operating pumps.

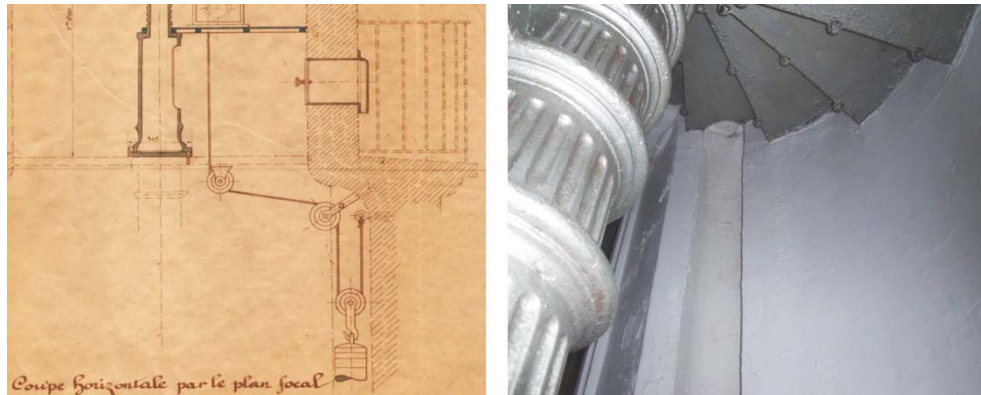
Figure 7: Weight system of the rotation system according to the 1911 project. Down chute of the weight of the rotation system of the optics screens today.

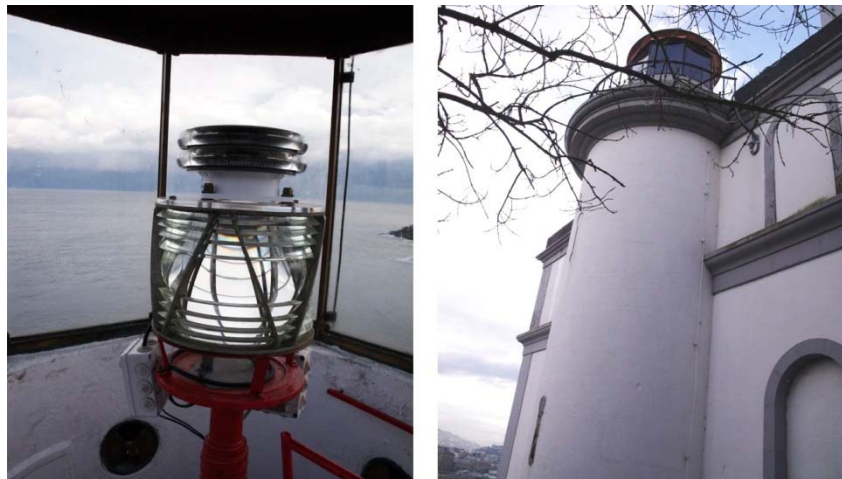
Figure 8: Acrylic optics of 2008 on white-coloured base placed on the optics implemented in 1943, with inclined struts (both work with flashes of the lamp with no rotation mechanism). Detail of the semi-embedded tower in the living quarters, office and store building.

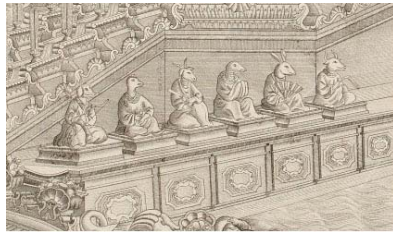
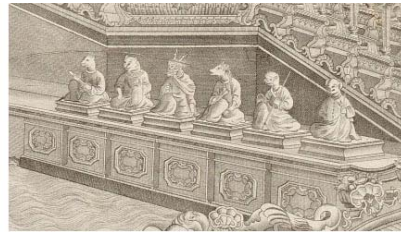
Figure 5. The water jets of Bronze twelve Chinese zodiacs in the fountain of Haiyan Tang (The Water Jets in the fountain of Haitan Tang, [11])

Although naked female sculptures embellish water jets in traditional baroque fountain design, Emperor Qianlong felt that such sculptures were not consistent with ancient Chinese customs. Thus, twelve Chinese bronze zodiacs replaced them as water jets. The sequence of twelve Chinese zodiac animals included a rat, ox, tiger, rabbit, dragon, snake, horse, goat, monkey, rooster, dog and boar. Odd numbered zodiac animals were set on the right side of the fountain and even numbered zodiac animals were placed on the left (Figure 5). A special timing unit called “Shi Chen” was constructed to control the water feature and was set at two-hour intervals; another setting was set at 12 Shi Chen, a period of the day. During each two-hour interval one of the twelve Chinese zodiac animals sprayed water from its mouth; all twelve Chinese zodiacs sprayed water at meridian hour. This combinational fountain was designed as a water clock fountain. These unique features made the Imperial Gardens prime property that was not only costly, but also highly sought after by the ruling class. Dashuifa (Figure 6) was another large-scale fountain and featured a special viewing deck on the opposite side of the general viewing area for imperial family members. Another feature was the Huanghua Zhen (Figure 7) labyrinth for imperial entertainment: imperial members commanded eunuchs or maids to walk the labyrinth as directed.

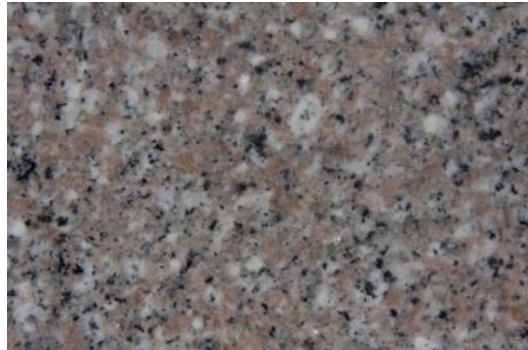
Figure 1: Plane image of the granite sample

The color identification method was used to calculate the mineral proportions. Regarding basic conditions for analysing rock images to determine the mineral compositions and relevant proportions, the minerals must exhibit recognizable colors and that the mineral particle size must be recognizable by software. Granite perfectly satisfies the conditions and is thus the most suitable material for image analysis for mineral proportion determination.

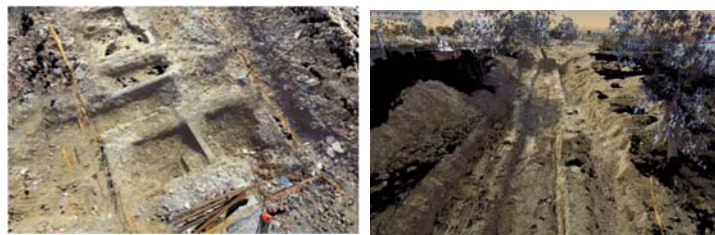
Figure 23: LCPS image of archeology site

Second application of LCPS is to measure the archeology site of Old Feng Shan City. The ruin of West Gate of the City is discovered in 2013. In order to record all origin state if this site, the LCPS is involved not only as an image recorder, but also as precision measure tool. Figure 23 shows the scanned image of the sites including West Gate and walls. Figure 24 shows the selected sections can be described with precise coordination by post processing of LCPS.

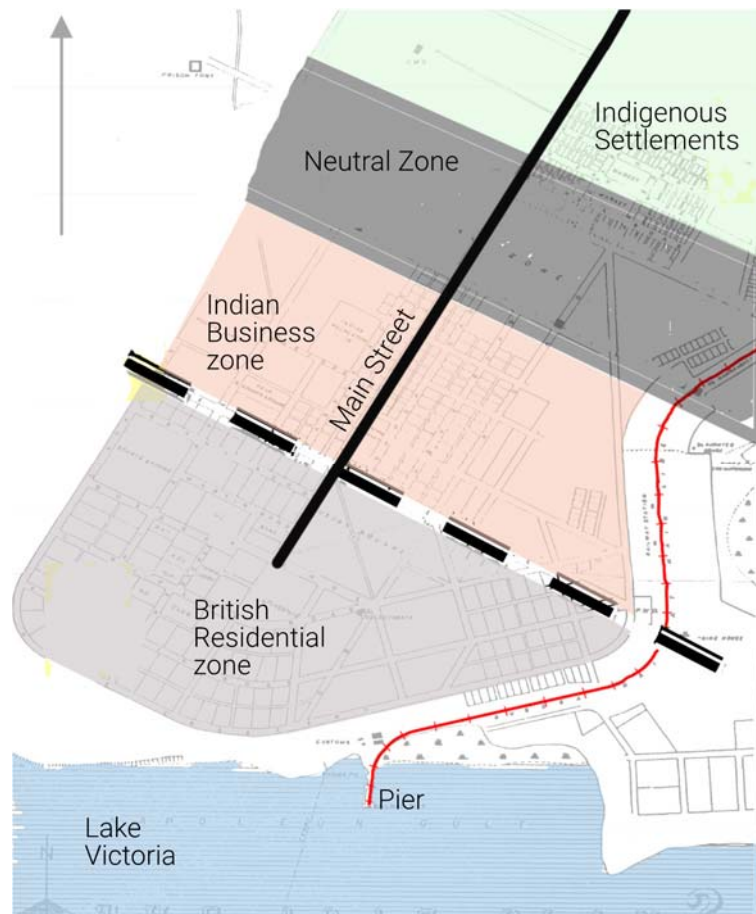
Figure 5: Jinja's urban zones 1917 [33].

Indian and indigenous urban residents were housed north of Boundary Road - Nile Avenue (dashed line in fig. 5). Key spatial developments located in this area entailed: a native hospital, clerk's quarters, Indian residences and a market. The eventual urban zones were influenced by colonial planning ideologies that pervaded urban space, complemented by racial hierarchy. When racial tensions simmered from about 1906 to 1914, Main Street was the only built up street that traversed the neutral zone (Fig. 5). Stretching about 1.8km, Main Street's trade activities had substantial contribution not only to the early 20th century Indian patrons that played a significant role in building its image but also to the evolution of Jinja within socio-economic context.

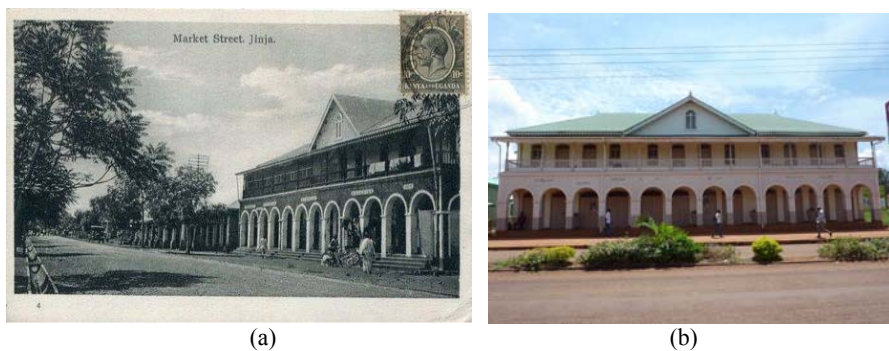
Figure 7: Madhvani Building: (a) in 1920s [36] and (b) in 2016 [author]

The Madhvani building was completed in 1919 and became the head office for Vithaldas Haridas & Company in addition to apartments on the upper level. It later became offices for Muljibhai Madhvani & Company and in 1947 was the headquarters for two sugar factories, eighteen cotton ginneries and a tobacco company. This building attains its significance as the cornerstone of the Madhvani business empire - one of the largest private-sector investor of industry in Uganda today. The latter (Fig. 8) was completed in 1924 and housed a bakery, under Indian ownership, then later became a kiosk and bar. This building currently houses a restaurant, library, craft store, as well as a prayer space.

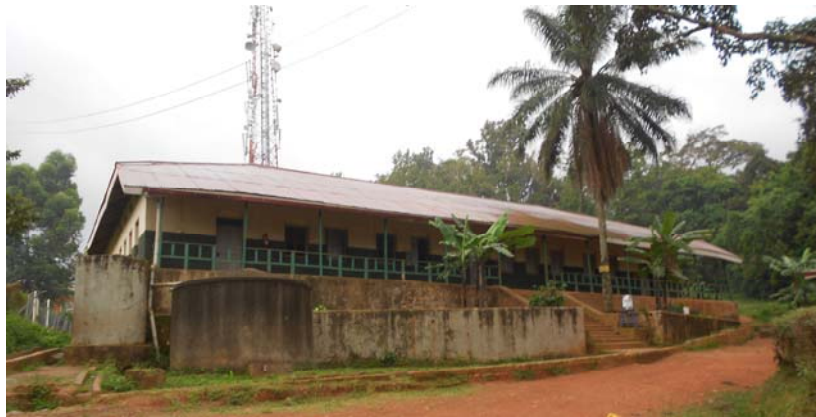
Figure 1: Chwa Building (Source: Author, 2018).

The two buildings in question were commissioned and constructed by the CMS, borrowing heavily from bungalow typology that had been established in the British Indian colony [12]. Both buildings were built using local materials – sun-dried mud and straw brick for the walls, palm poles for the roof truss, and thatch for the roof, required a substantial Bakopi (peasants) labour force [15], as this mode of construction was largely unknown, and required significant attention.

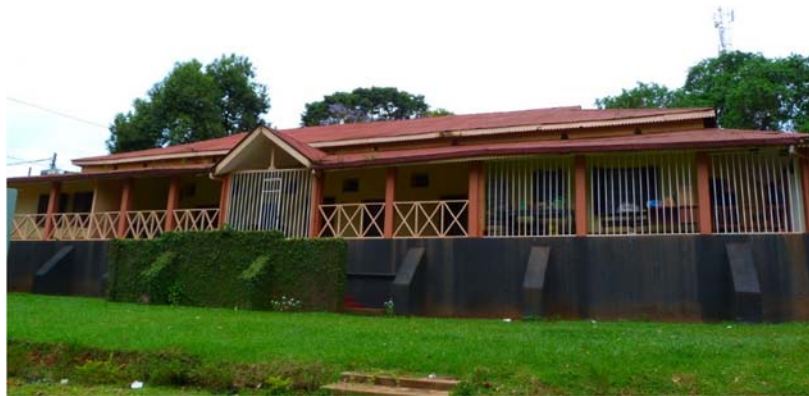
Figure 4: Keweerimide House in 2017 (Source: Author, 2017)

Keweerimide House (Fig. 4) was the official residence for Ham Mukasa, the Private Secretary to Apollo Kaggwa. The house, also in Mengo, was originally constructed in the late 1890s using sun-dried mud and straw brick for the walls, palm poles for the roof truss, and thatch for the roof. As a Private Secretary to Apollo Kaggwa, Mukasa had travelled to England in 1902 to attend the coronation of King Edward VII. He too was struck by the homes he had visited during his visit to England, and on his return to Buganda, set about remodelling Keweerimide House to incorporate some of the ideas - internal bathrooms and electric bells - he had seen.

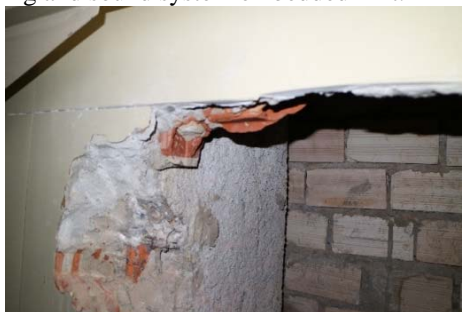
Figure 3: Prospecting at the South tower, Northwest gable. (Source: the autor, 2018.)

The internal prospecting of the Northwest façade confirmed the existence of double walls, according to the original designs. The outer wall, the support of the façade cladding system, is made of 6-hole ceramic bricks and dimensions of 14 cm x 19 cm x 9 cm of light brown colour, which probably indicates a brick of high burning and greater resistance. The masonry type of seating observed is very common in external vertical wall systems due to resistance and watertightness improving. The internal masonry, in its turn, has 8-hole clay red ceramic bricks of 19 cm x 19 cm x 9 cm. (Fig. 3, Fig. 4). It is also possible to observe at Fig. 3 the pillar of concrete and steel located between the double walls.

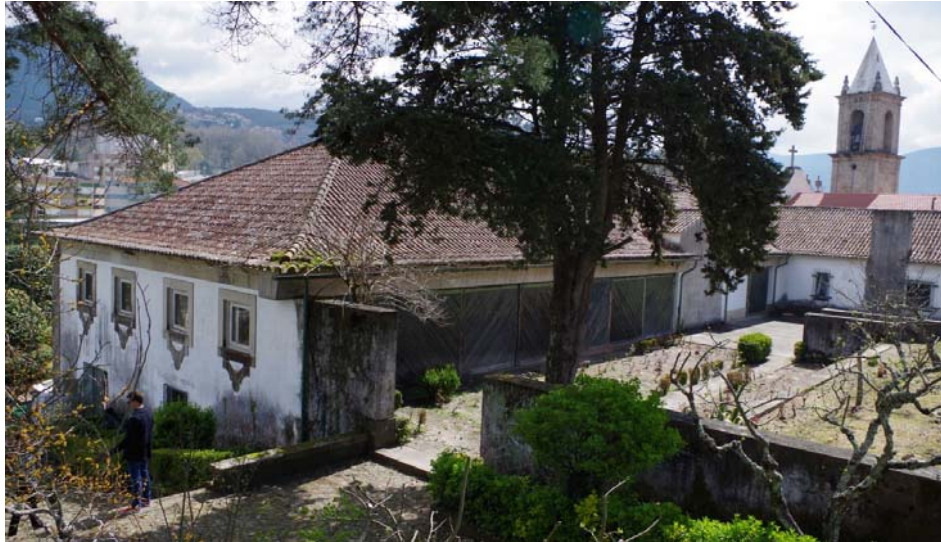
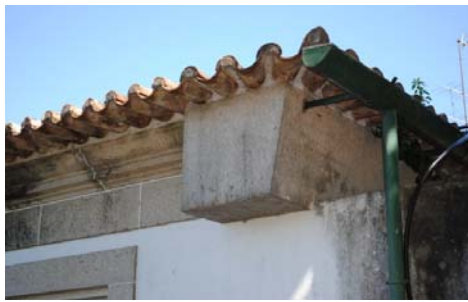
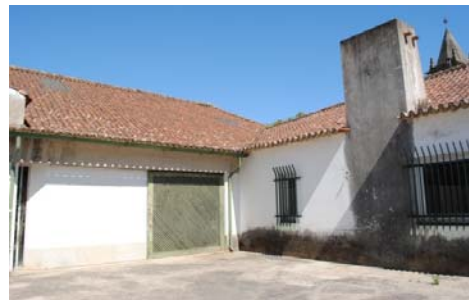
Figure 6: In the image above, view of the northwest wing, with the wooden latticework facing de backyard. Bottom left: detail of the meeting between the baroque cornice and the beam of the alpendre. Bottom right: latticework of the dining room, facing the backyard.

Távora's involvement in the *Inquérito à Arquitectura popular em Portugal* allowed him a deep knowledge to the popular architecture of the northern region of the country. Undoubtedly, when designing the new porch, the architect had in mind the functional and tectonic scheme of the vernacular house (*casa de lavoura minhota*), characterized by the *varanda*, a covered but open space, which was an essential frontier between the public outdoor space and the privacy of the interior rooms.

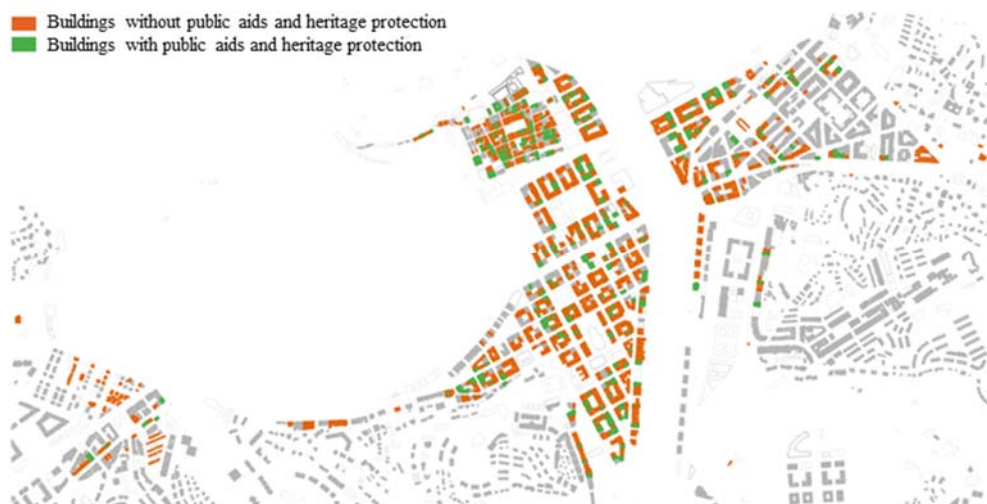
Figure 5: Distribution of protected buildings rehabilitated with or without public aid

Finally, the relation between the heritage protection level of a building and the distribution of refurbishment public aid has been analysed in fig. 5. The prevailing colour is red, which represents the protected buildings that have not received public aids for refurbishment purposes. Although there are several protected buildings that have received aids, mostly in the Old Part of the city because it was declared as Integral Rehabilitation Area (IRA), there is no concentration or clustering of them.

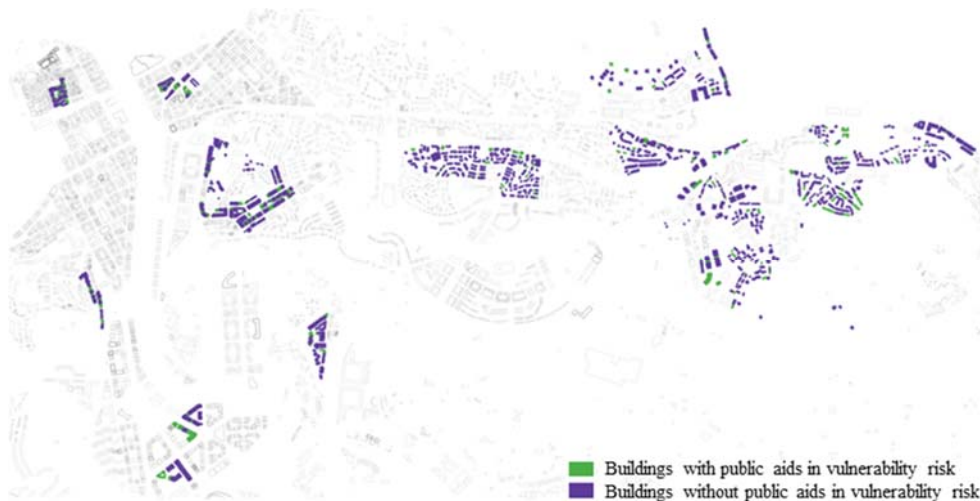
Figure 6: Distribution of interventions in socio-economic vulnerable areas

Comprehensive or energy purpose refurbishment programmes (REVIVE, RENOVE EE and PAREER) have reached few vulnerable areas. Only 16% of the houses subsidised by the PAREER programme are located in areas with very high level of vulnerability, 19% if all vulnerable areas are considered. Meanwhile, RENOVE EE has been fully distributed among non-vulnerable areas. In this regard, medium and high level of vulnerability areas have not received any public aid (Fig.7). Meanwhile, small refurbishment programmes (RENOVE programme for communities and individuals) have been distributed more equitably between the different vulnerability levels: 7%, 6%, 6% and 10% in low, medium, high and very high vulnerability areas (table 2). However, most of the subsidised dwellings (71) are located again in non-vulnerable areas.

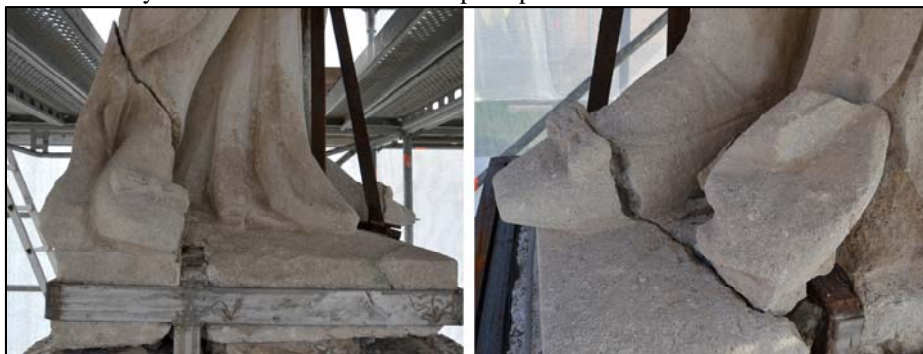
Figure 3: Statue of Ariosto disconnected at the base after cleaning the stone and removing the cement mortars

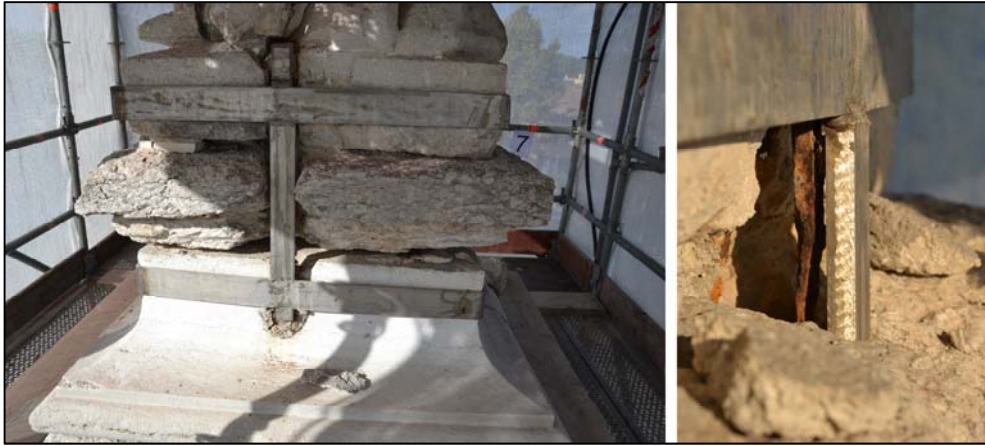
Figure 4: Podium of the statue. The external metal support ring in stainless steel has been welded to the damaged parts, accelerating oxidation.

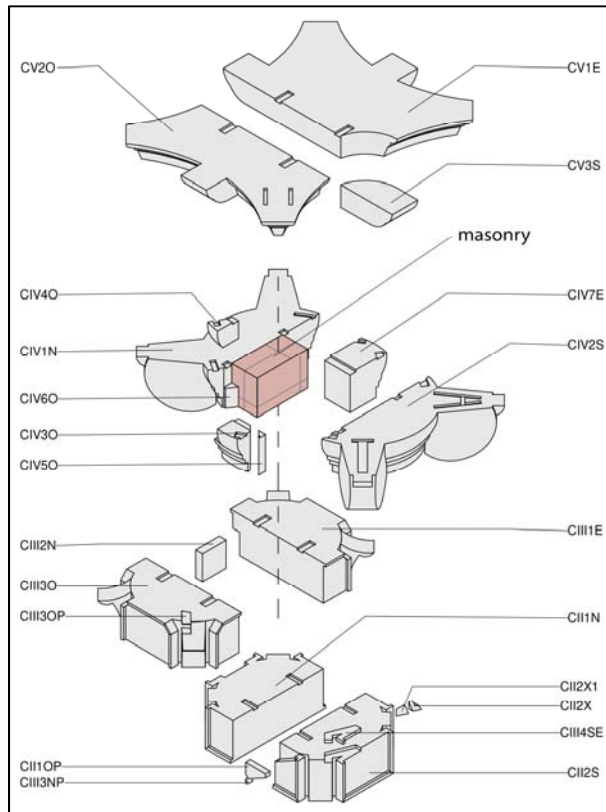
Figure 5: Exploded axonometric view of the capital drawn up following the dismantling of the various elements and preparation for their repositioning.

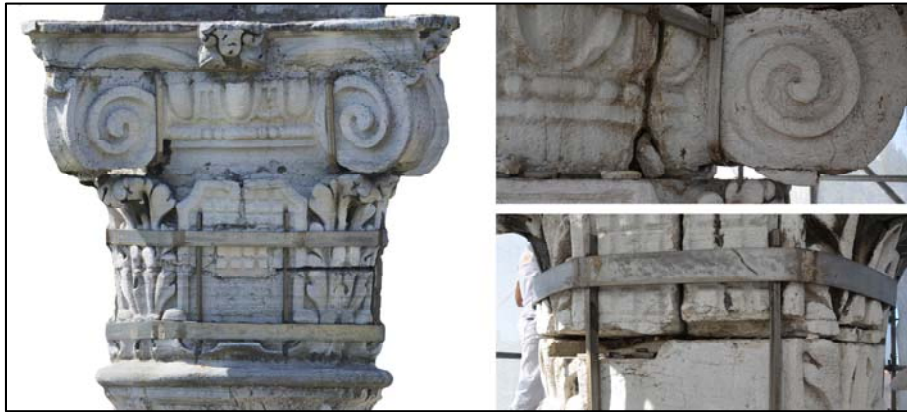
Figure 6: Capital of the column before the restoration works.

The capital of the Ariostea column is made up of a series of four elements placed on top of each other, each of which constitutes various stone elements, positioned on the monolithic shaft (Fig. 5). Each stone element had detached with cracks a few centimetres wide (Fig. 6) due to the stone jacking caused by the expanding metal inside (Fig.7).

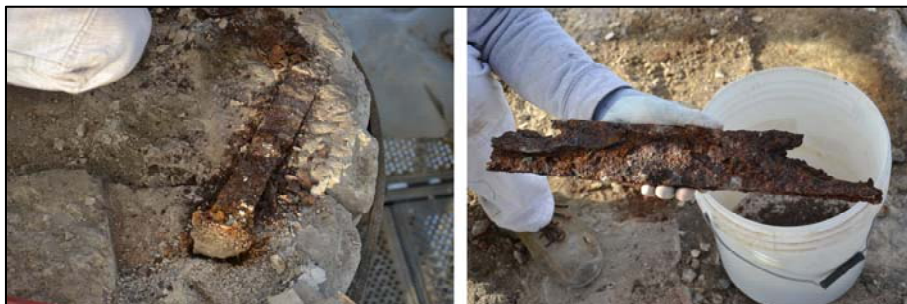
Figure 7: Oxidation of the internal fixtures between the parts which define the individual stone elements of the capital.

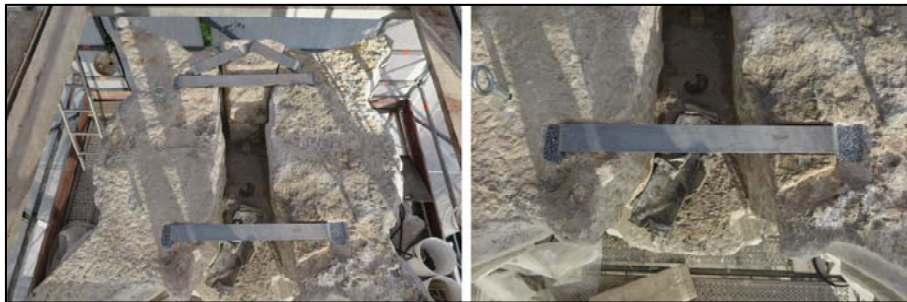
Figure 8: New cramps in duplex stainless steel connecting the various elements of the capital.

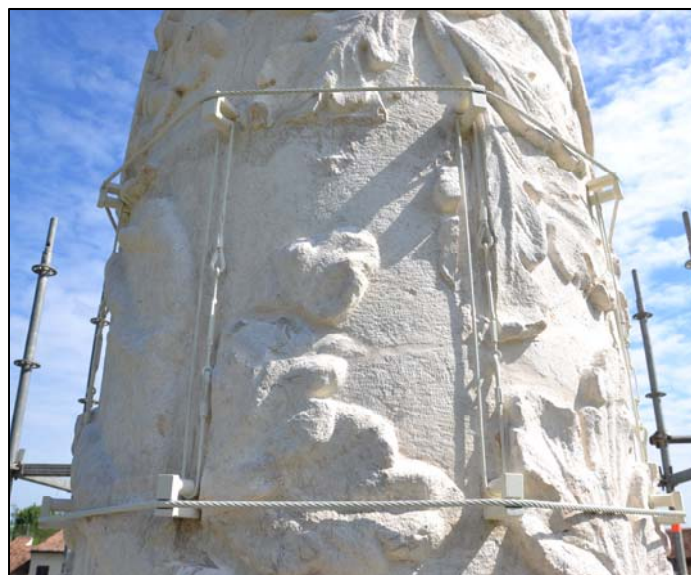
Figure 9: Stainless steel cables used to strengthening in flexure the shaft.

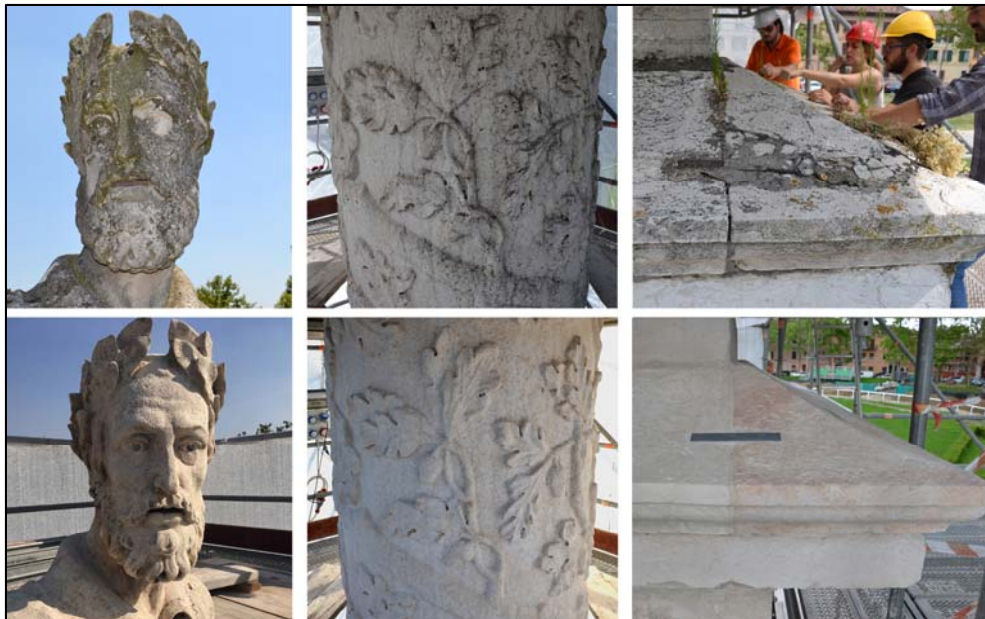
Figure 10: Operations to clean the surfaces of the statue, shaft and pedestal.

The architectural surfaces were cleaned using biocides, clay poultices and manual techniques to remove superficial deposits, incrustations and the presence of biological staining. The incompatible elements were also removed (metal cramps and cement mortars) and the cracks and gaps were filled using special natural mortars mixed up on the site. They were then treated superficially with a thin coating (Fig. 10). As a final operation, the whole surface of the statue was treated with protective products, in particular to protect it against graffiti.
