PERMITTING SIGNICANT HARM IN THE CONSERVATION OF HERITAGE ASSETS: CONFLICTS IN SUSTAINABLE LAND USE PLANNING DECISIONS

DR HAZEL ANN NASH

Centre for Engineering and the Built Environment, Birmingham City University, UK

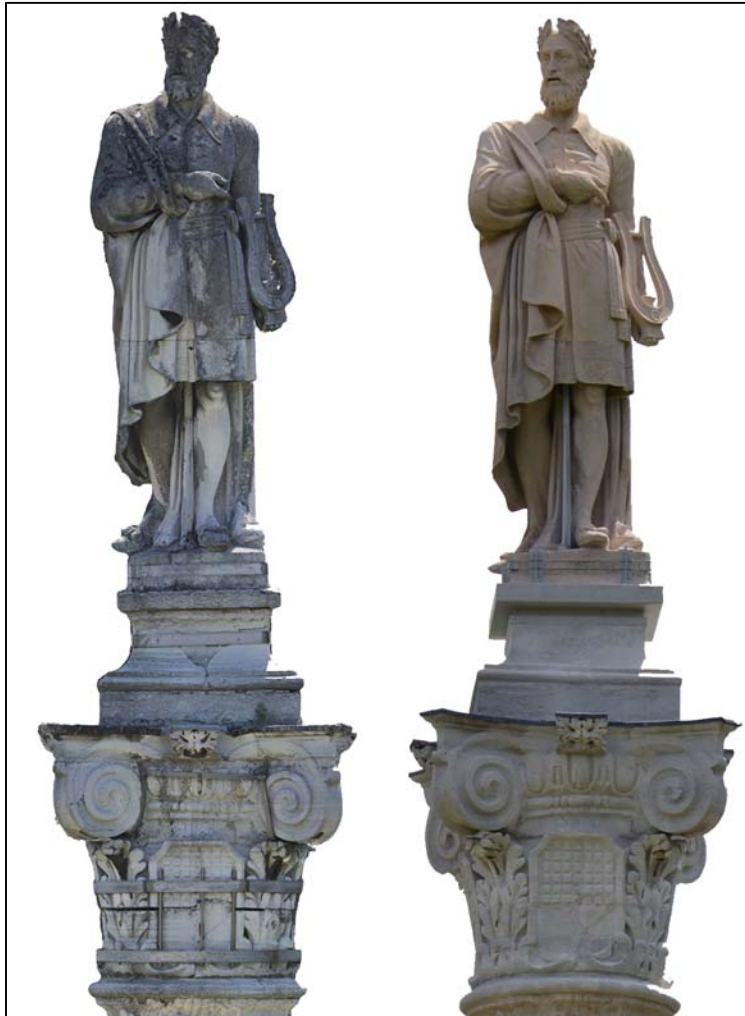
Figure 11: the capital, the podium and the statue before (left) of the restoration work and after (right).

The objective of returning the monument to the community, which required both structural and superficial restoration, was pursued through a circular process of understanding and conservation, and was fulfilled based on critically evaluated choices to recuperate the monument's visual unity and consequent capacity to reveal itself in each and every one of its elements: “la esigibilità del monumento” (Fig. 11).

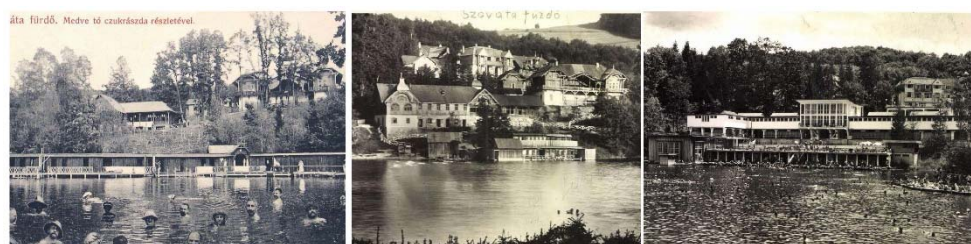
Figure 10: Upper resort main building evolution in Sovata 1900-1941

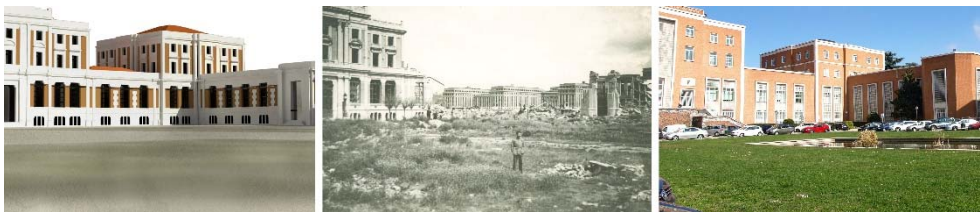
Figure 1: School of Agriculture Engineering in 1930-1939-2015. Drawing: J. Muñoz. Old photography: *ETSIAAB. UPM*. Current photography: J. L. González.

Afterwards, a time comparison has been made for each building existing in the campus before the war, using drawing or photography – as explained above – depending on the case (Fig. 1). We have detected different ways of reconstruction according to which the buildings have been classified. Due to the limited length of this text, we offer here only some examples of each case. However, a summary table with every building is included at the end.

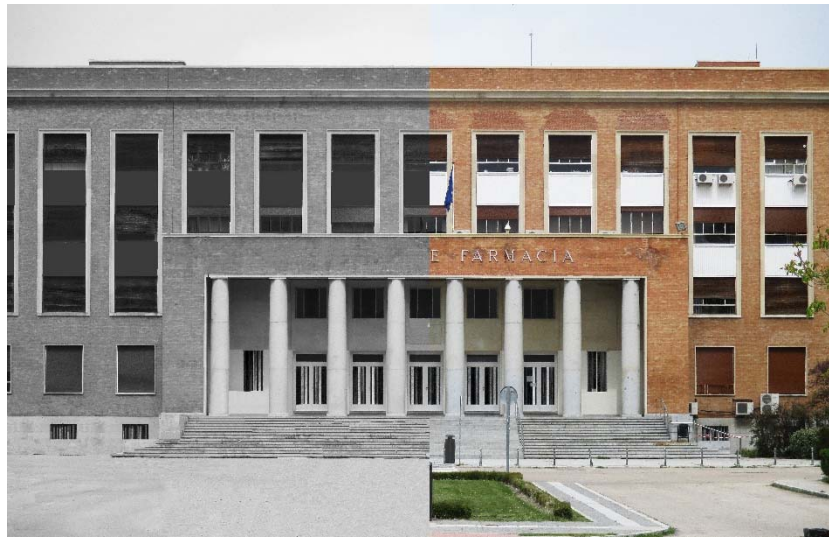
Figure 5: Façade of the Faculty of Pharmacy in 1936 and 2018 (J. L. González).

These buildings were basically finished before the war. The medical campus was placed at the very front line during the war, reason why it suffered important damages which especially affected the Faculty of Odontology because of its forefront position. The other two faculties also suffered damages in their southern and eastern façades.

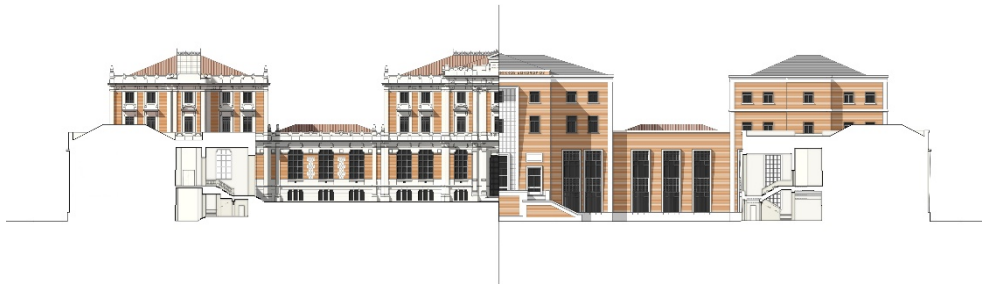
Figure 6: Façade of the School of Agricultural Engineering in 1936 and 2019 (Graphics Department ETSAM, 2007; A. Bonet, 2010; J. Muñoz, 2018).

The other great modification that the School of Agricultural Engineering experimented regarding its prior state before the war is related to the topography of its surroundings. Currently, the building is placed on top of a continuous, flat platform. However, before the war, there was a great difference between the level at which the main façade of the building was located - at a higher level - and where the back façade of the building was, approximately three metres below. This way, whilst the front of the building was only one level high (the towers were three levels high), the back façade had one extra level to it. This unevenness was solved by means of staircases placed adjacent to one of the side façades. Thus, the building, on the one hand, adapted more subtly to the irregular land of La Moncloa and on the other hand, it presented a more pleasant and welcoming façade towards Madrid with its smaller scale. The variations in the topography during the post-war, are the origin to some situations which can cause confusion to the visitor if he/she does not know the history behind the building. For example, the large staircase at the front façade - scarcely related to the rest of the building - or the fact that one does not access the main floor from street level.

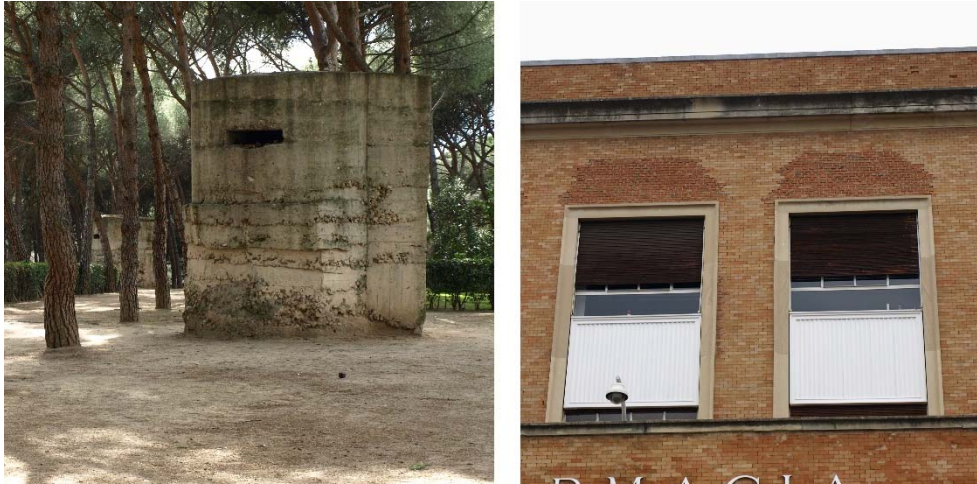
Figure 7: Bunkers in Parque del Oeste. Façade of the Faculty of Pharmacy (J. L. González).

On the one hand, as a remain of constructed elements, we find the striking three bunkers located in the Parque del Oeste. They were carried out by the rebel troops during the last year of the war to consolidate the Frontline. Their quite good condition allows us to see the inscriptions done on them by the soldiers (Fig.7). Although less visible, other constructed elements are the remains of the old trenches. In certain areas, what seems to be the natural topography of the place is actually the consequence of the digging of trenches. In the last years, some of them have been excavated, revealing abundant war material [8].

On the other hand, there are still many destruction signs in the damages caused by the impact of projectiles against various buildings and constructions. The ones which are most evident are those found in the granite plinths of the faculties of Philosophy, Medicine, Pharmacy and Odontology. The diameter and depth of the marks are a clear proof of the great variety of weapons used during the war. Also some of the reparations on the buildings do give us some clues. For example, the bricks with a more intense colour of the Faculty of Pharmacy are the evidence of the impacts which do not prevail (Fig.7). Finally, the Faculty of Medicine is one of the few buildings where one can still see today impacts directly on the brick of the cornices. It is also very revealing that the western orientation is considerably more damaged than the rest of them, since it makes it clear that the enemy fire came from the School of Architecture.

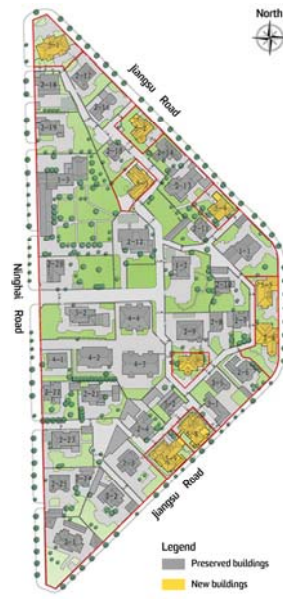
Figure 4: The master plan of Yihe Mansions (Source: Nanjing Urban Planning Bureau.)

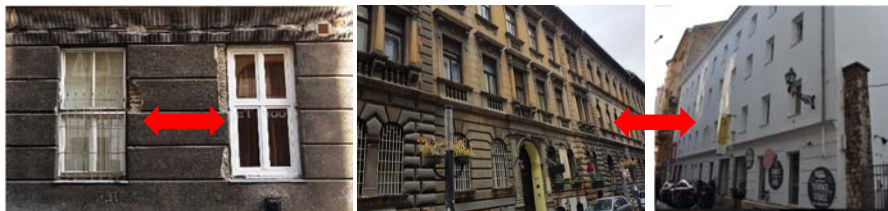
Figure 3: Energetic retrofit with no consideration to heritage value. The original ratios and ornaments are destroyed

To avoid the mistakes shown on Figure 3, the limits of the retrofit should be included. These include the problems of the dense urban fabric, and also the monument protection guidelines, which should be applied to maintain the architectural values and character.

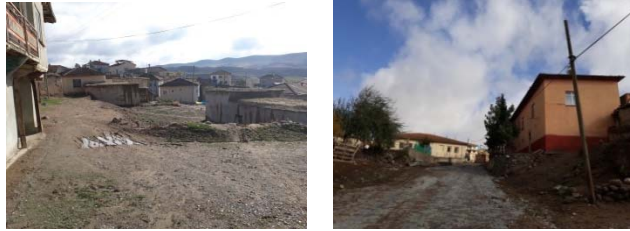
Figure 7: An earthen and a cobblestone ways

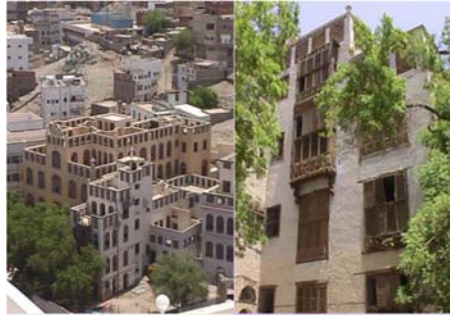
Figure 2: Pictures of Bin Suleiman's Palace Buildings from the outside

The rise of the part that forms the ceiling is noticeable in the facades of the southern building, alongside the use of decorations and motifs in the northern one. One can also notice the use of colored brick in slabs and surfaces, as well as the chimney configuration and cylindrical ventilations for bathrooms and kitchens from the upper surfaces. Wrought iron was also used in the lower floors and open parts of the Roshan and windows for security reasons.

The building is rich with motifs and gypsum designs that came to existence through decoration works on ceiling screens, door and window frames, and interior ceilings. In addition to coloring and dying works and drawing on reception room and bedroom walls and bathroom domes. The building is a true architectural masterpiece reflecting a side of Makkah's urban heritage in the middle of the 14th Century AH [7].

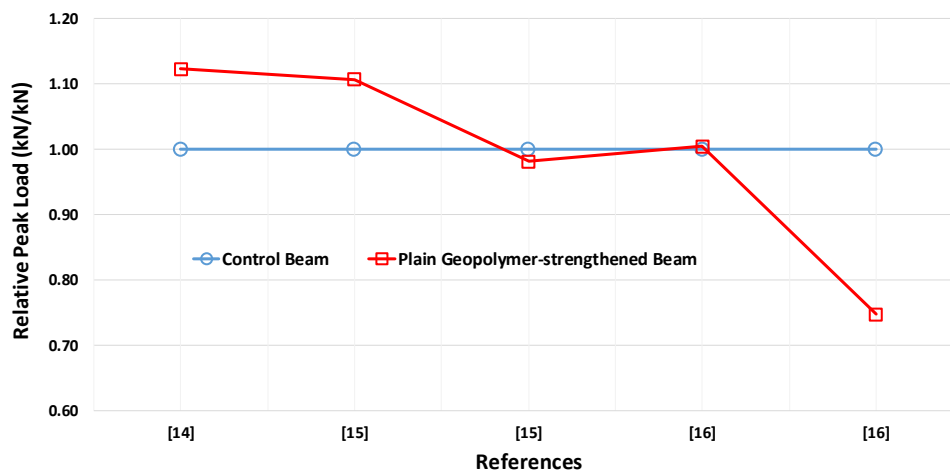
Figure 1: Peak load performance of plain geopolymer-strengthened beam

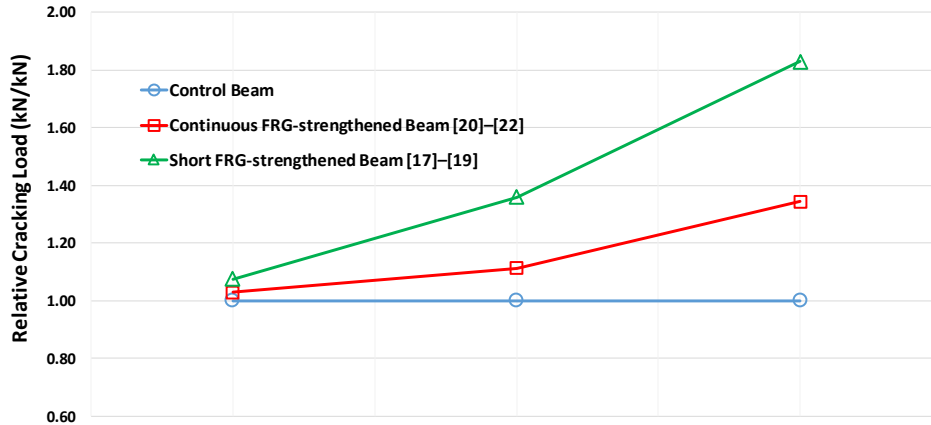
Figure 2: First cracking load performance of FRG-strengthened beam

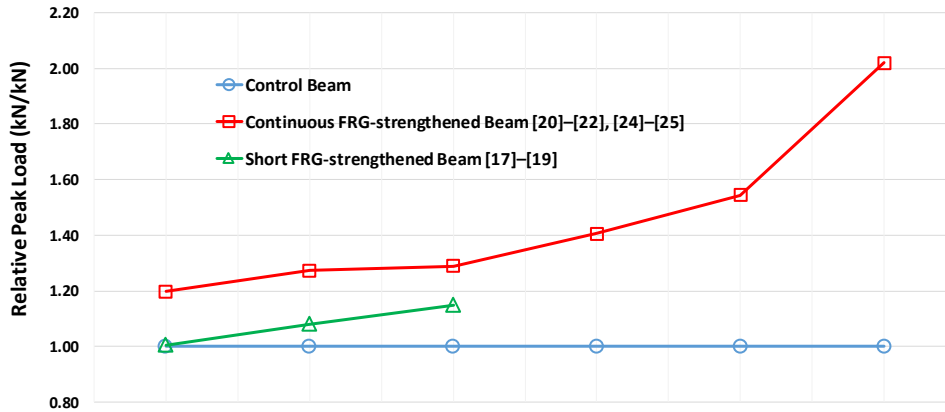
Figure 3: Peak load performance of FRG-strengthened beam

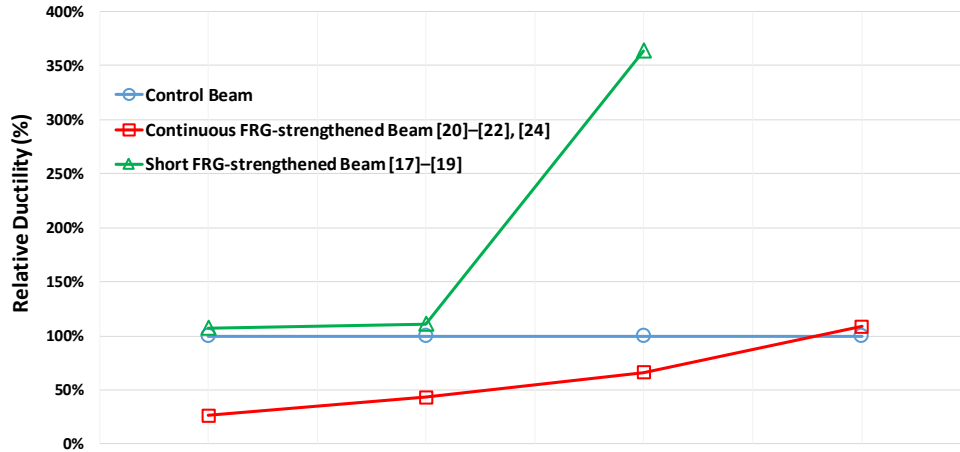
Figure 4: Ductility performance of FRG-strengthened beam

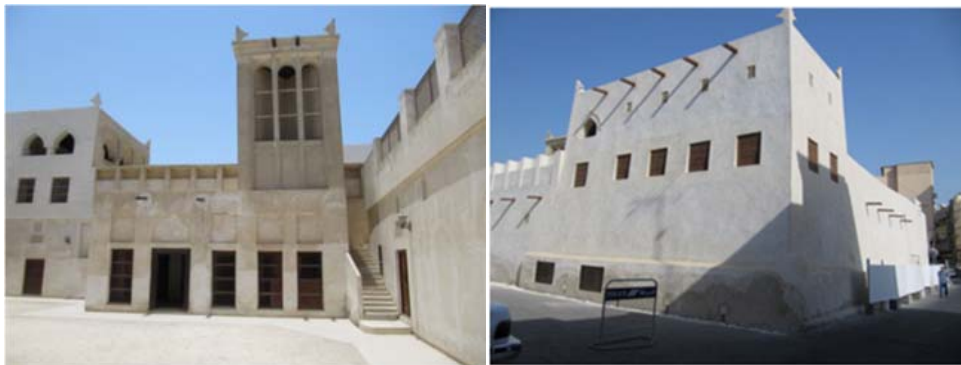
Figure 1: An example of a traditional Bahraini house with a central courtyard

Figure 2: An example of the external facade of a traditional Bahraini house

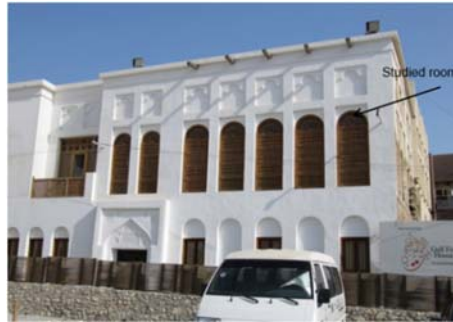
Figure 5: North facade of Al-Zayed's house showing the mashrabiya screen

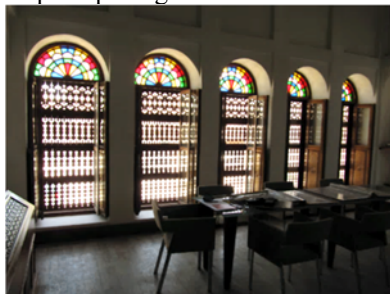
Figure 8: The five equal openings of the mashrabiya at the studied room of Al-zayed house

The studied room of this house was located on the second floor. The openings of this room faced north and were covered with five equal-sized traditional screens (mashrabiya) (Figure 8). Each window opening covered with mashrabiya was 175 cm in height, 82 cm in width, and 20 mm in depth. They were of a brown colour with 34.7% reflectance and the perforation ratio of the mashrabiya was 22%. This percentage was calculated using a photograph taken of the mashrabiya with light passing through the openings. This created a strong contrast between the brown wooden part of the mashrabiya and the openings. The Fiji Image J program was used to count the pixels of the lighter areas, which helped to calculate the percentage of the irregular-shaped openings.

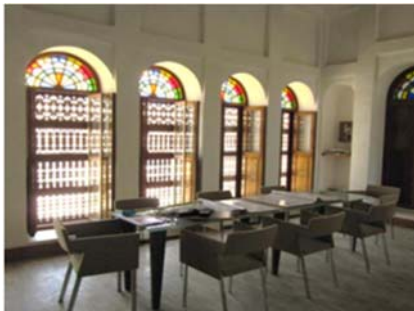
Figure 13: An actual picture of the room at 9.00 am

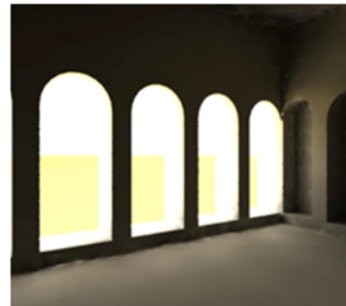
Figure 14: A ray-traced image of the room without mashrabiya at 9.00 am (Prepared using Ecotect and Desktop Radiance)

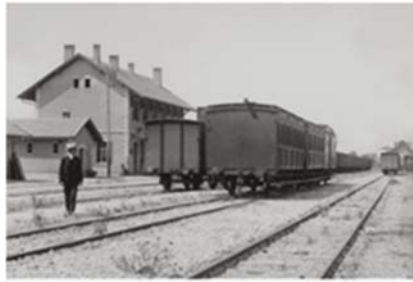
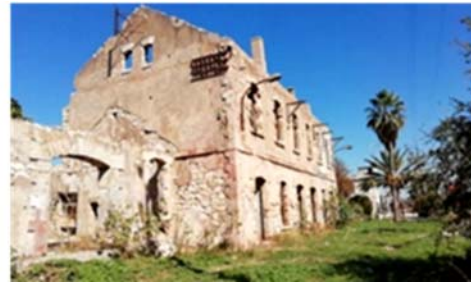
Figure 3: The Train Station. (a) In 1920; (b) in 2018.

In 1975, the station had suffered tremendously during the backlashes of the civil war, and had completely stopped working ever since. Its devastating state is worsened as time went by, and what remains of it can still be witnessed today: The cracked walls, broken windows and shattered roofs, barely hanging in place, due to the lack or complete absence of maintenance efforts and renovation strategies; Fig. 3(b).

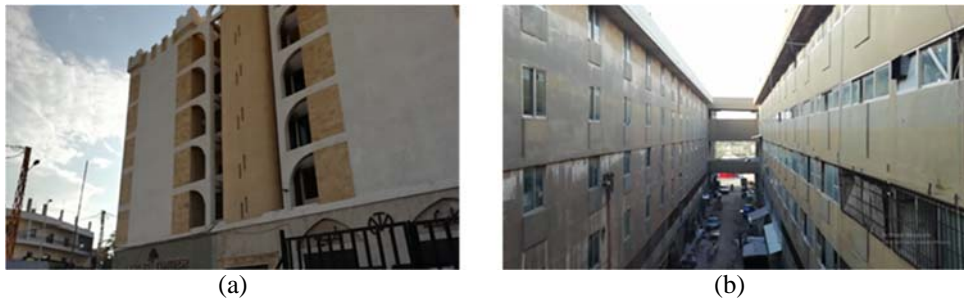
One particular industrial building to highlight here is a concrete ‘giant’ structure, which rises three levels high with a total elevation of approximately seventeen meters; Fig. 6(b). The three levelled building is basically a two strands of concrete structures incorporating, on each floor, a series of workshops for furniture manufacturers with an attic ring sitting on top of the workshops beneath.

Figure 6: Industrial buildings within the site. (a) Timber factory; (b) the concrete ‘giant’.

An appeal to this building would be the inner circulation that is shaped by two bridges connecting the two strands with each other, one resting flat while the other is basically a ramp looping over the open space in the heart of the building. These bridges were designed to carry out vehicular circulation allowing access for service trucks to reach the top of the building, besides on foot access. Additionally, one staircase is found inside each of the two structures, essentially leading the workers upward to their different stationeries while shortening the loopy distance.

Unfortunately, as is the case with almost all buildings in this hiatus, this particular structure is in a dreadful state, to the point where one might see the reinforcements of steel bars hanging out of many of its columns as well as floors. However, there is an undeniable potential of transformation, found in the physical entity and the space within, that might produce an outstanding experience for both visitors and workers. This will lead this structure to play a central role in our proposed intervention.

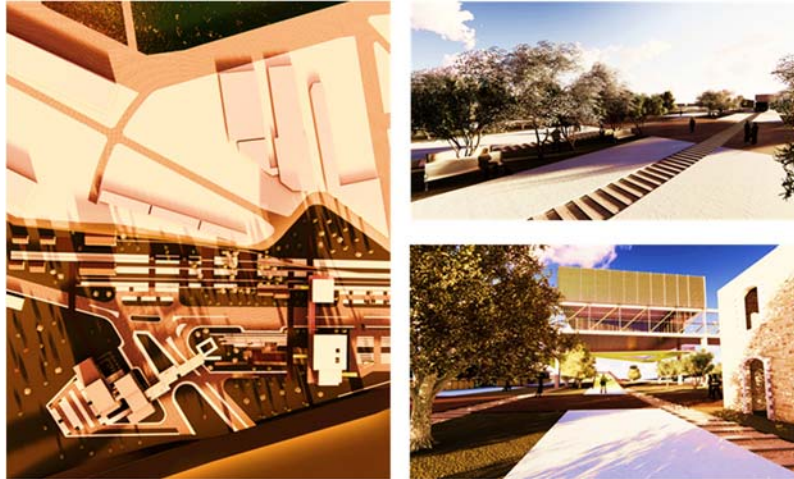
The district under consideration will assume as its base layer a comprehensive park upon which the other layers of paths, interactive spaces, and functioning buildings will be superimposed. The acute lack of green and public spaces in Tripoli naturally drives towards such an approach. The train station site on the northern side will consume the bigger part of the park which will be lined up with prolonged promenades, along the lines of the historical railway roads, connecting the old structures of the station after transforming them into exhibit spaces and follies. The green scape in the southern part of the site submerges with the

buildings at times, and surrounds them at others, creating thereby a potential environment for interaction with the industrial and public services within the buildings; Fig. 10.

Figure 10: The conception of a park with layers of green areas, pedestrian paths and bridges, and buildings for crafts innovation and production.

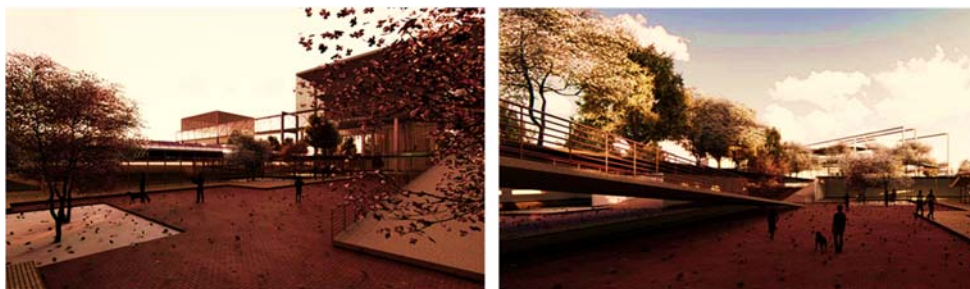
In our intervention, communal spaces are not limited to public outdoor space but can be part of the buildings themselves, either piercing a building through a public galleria, or overlapping with the interior space proper. Public communal spaces can be sunken (Fig. 11), can bridge over vehicular streets as floating platforms, or can be part of a bridging building itself. All these different combinations are expected to provide a varied and rich palette of spatial and urban experiences within the overall setting of a public park.

Figure 11: The sunken plaza.

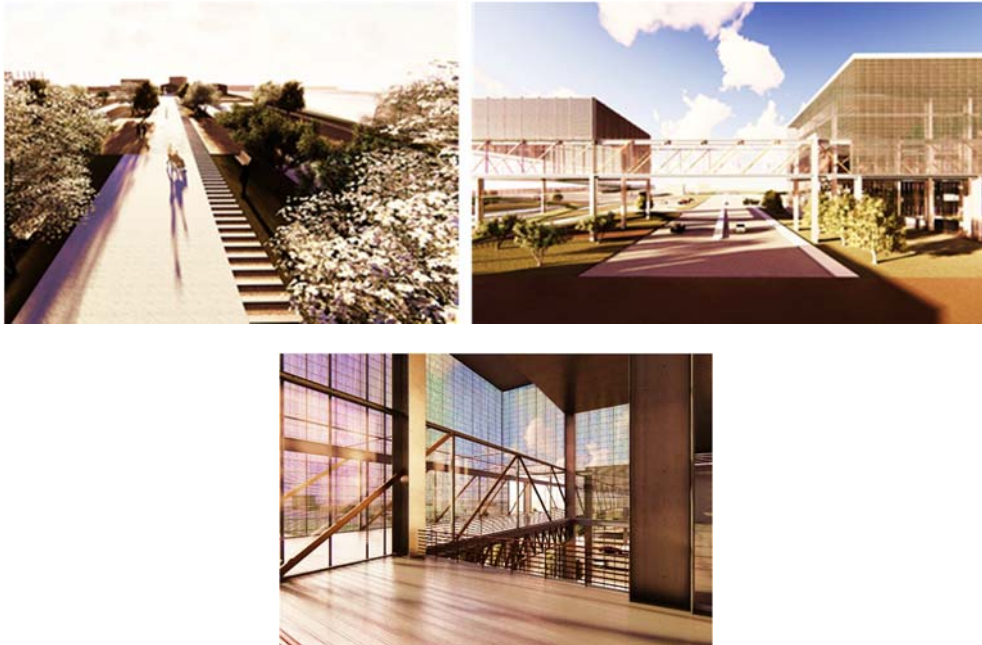
The pedestrian pathways knit together the building and spatial components, bridging sometimes over vehicular streets, and passing through architectural structures at other times. What results is a continuous looping promenade manifesting itself through a sequence of paved paths within the landscape, ramping platforms, and floating linear spaces (Fig. 12).

Figure 12: Variety of pedestrian paths.

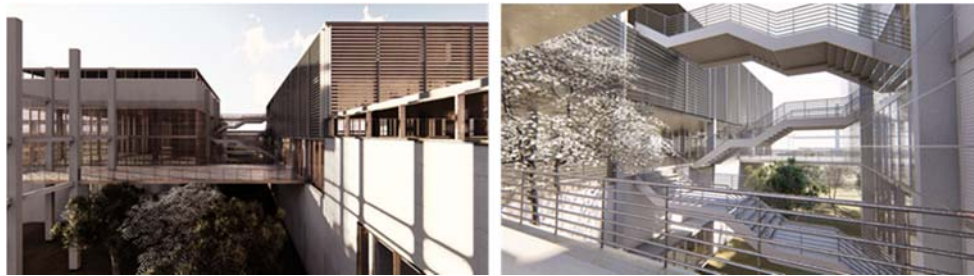
The old stone buildings of the train station are either transformed into small galleries and exhibition spaces, or into a number of follies that enrich the experience of the public park. From the railway station, pedestrians cross towards the concrete 'giant' building which previously housed workshops and work yards, but is now transformed into an Innovation Centre for product design, receiving designers, craftsmen, as well as public visitors. The

monolith of the building itself is stripped out of its massiveness and traversed by a galleria in addition to its internal atrium (Fig. 13). The building then breaks into different public platforms that bridge over another vehicular street, unto a sunken public plaza that provides access to a couple of showrooms. Through the open-air sunken plaza, the journey continues up into the semi-public circulation and exhibition spaces within the new Production Centre bridging again across the main vehicular street, and then ramping down back into the railway station. This loop is expected to assure maximum interaction between the designers, the makers and the consumer public, and is meant to dramatize the urban/architectural experience and ground it in the spirit of heritage and history.

Figure 13: The redesigned concrete ‘giant’ building.

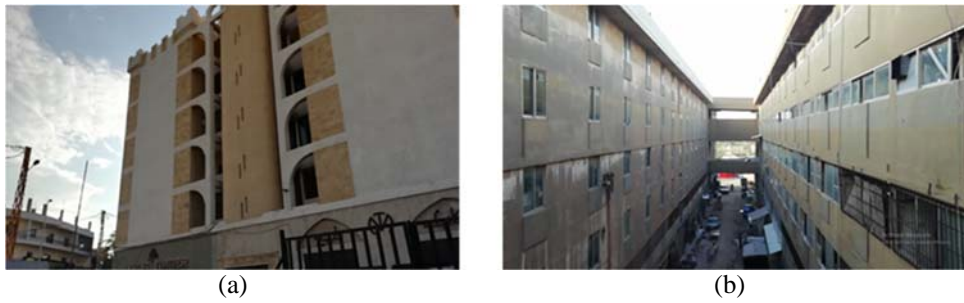
One particular industrial building to highlight here is a concrete ‘giant’ structure, which rises three levels high with a total elevation of approximately seventeen meters; Fig. 6(b). The three levelled building is basically a two strands of concrete structures incorporating, on each floor, a series of workshops for furniture manufacturers with an attic ring sitting on top of the workshops beneath.

Figure 6: Industrial buildings within the site. (a) Timber factory; (b) the concrete ‘giant’.

An appeal to this building would be the inner circulation that is shaped by two bridges connecting the two strands with each other, one resting flat while the other is basically a ramp looping over the open space in the heart of the building. These bridges were designed to carry out vehicular circulation allowing access for service trucks to reach the top of the building, besides on foot access. Additionally, one staircase is found inside each of the two structures, essentially leading the workers upward to their different stationeries while shortening the loopy distance.

Unfortunately, as is the case with almost all buildings in this hiatus, this particular structure is in a dreadful state, to the point where one might see the reinforcements of steel bars hanging out of many of its columns as well as floors. However, there is an undeniable potential of transformation, found in the physical entity and the space within, that might produce an outstanding experience for both visitors and workers. This will lead this structure to play a central role in our proposed intervention.

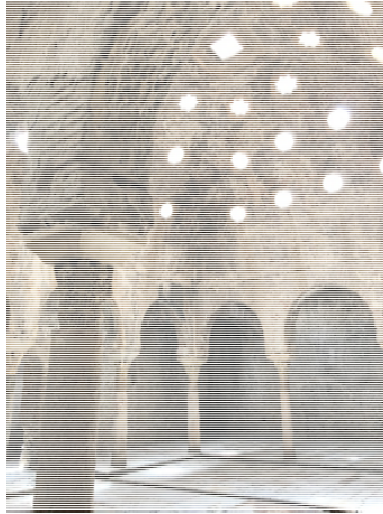
The bath is mostly built with lime concrete walls and brick vaults, along with octagonal and star-shaped oculi to allow light in and to control the steam generated in the hot room (Fig. 1). Water was supplied from the north end, along a branch of the Axares irrigation channel, and ran out to the river Darro along a brick drain.

Figure 1: Warm room of El Bañuelo (Photo: J.M. López-Osorio).

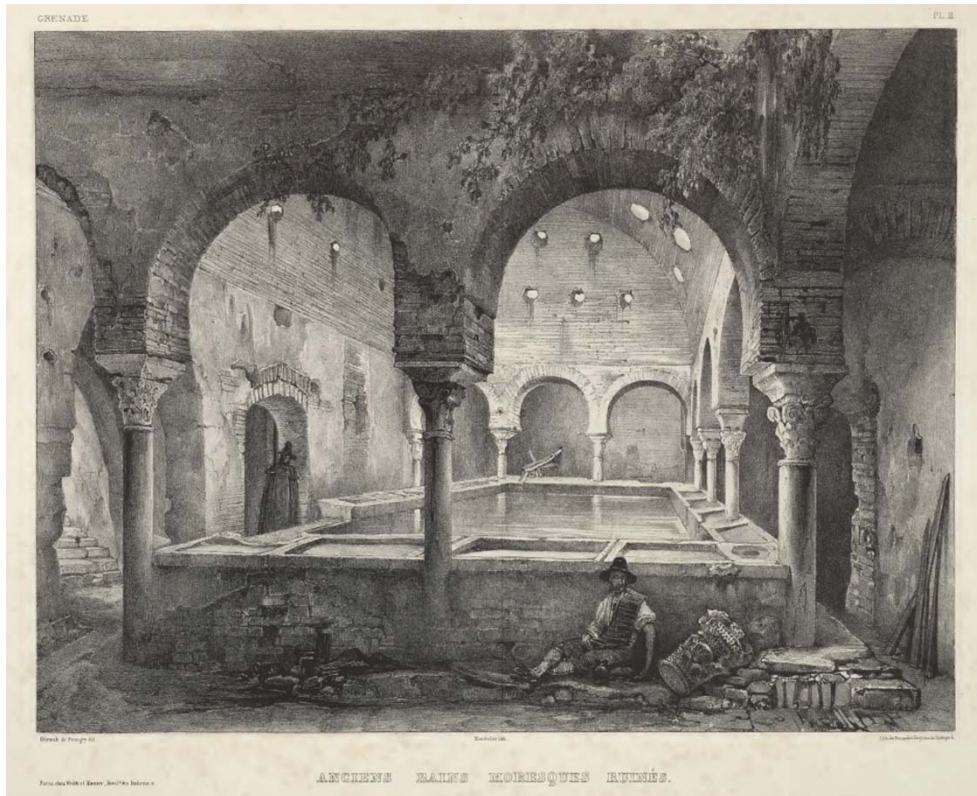
The most detailed engraving, entitled “Anciens Bains Moresques Ruinés” (Planche 11) (Fig. 3), shows a view of the warm room taken from the west side. A public laundry can be seen in the middle alongside an interior pool. The accompanying text provides a brief description of the use of the building, although it is somewhat inaccurate and interprets the hot room as the relaxation room and the service quarters as the garden. This may have been due to the thick vegetation which apparently grew on the rubble from the collapsed vault. One of the most important contributions of the engraving is that it shows the wall separating the warm and hot rooms, with a large round arch to the left of the connecting door. This opening may have been designed to widen one of the original conduits of one of the hypocaust chimneys, which was probably damaged. This opening, which also appears on the floor plan described above, shows it as a break, providing a glimpse of the modern staircase occupying the space of the former hot water tank and connecting the hot room to the wood store above. Another detail to note in the engraving is the wooden gutter supplying water to the pool from a hole in the east wall of the room. This water supply point can still be seen today in the form of slightly overhanging brick and is especially interesting as it shows that water was supplied to the bath from this side of the present Calle del Bañuelo. A break can also be observed in the southern section of the vault of the west portico. Furthermore, in addition to different details of the Alhambra, engraving number 22 also shows two capitals from the warm room, one of which features Arabic inscriptions in the abacus. Remains of these inscriptions are

still found on the capital of one of the columns of the south gallery of the warm room, to the right of the entrance from the cool room.

Figure 3: Warm room of El Bañuelo (after J.-Ph. Girault de Prangey, 1837).

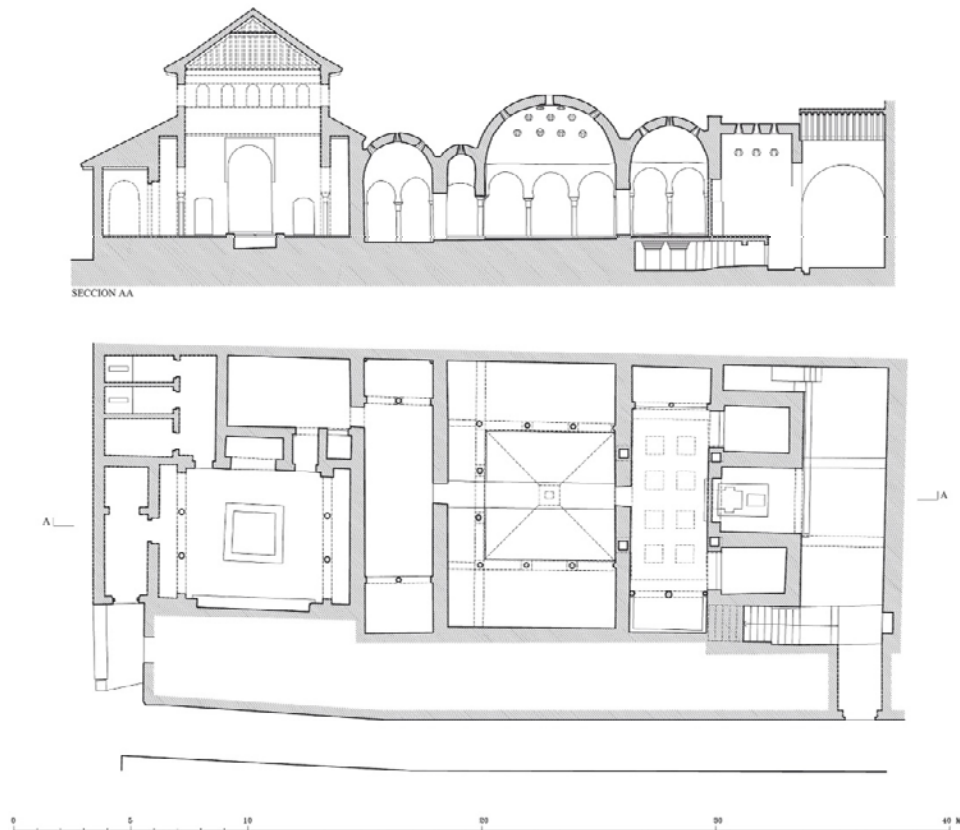
Figure 10: Hypothetical original ground floor plan and cross-section of El Bañuelo (After A. Almagro-Gorbea, 2014).
